Repeat failure in disassemble of a simple machine used to install a leaf spring to a car gas filler neck recess cover flap - see inset picture.

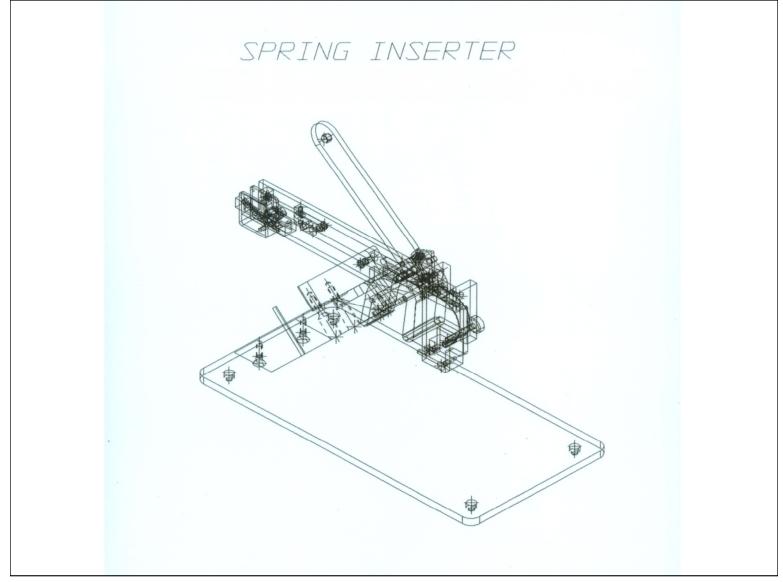
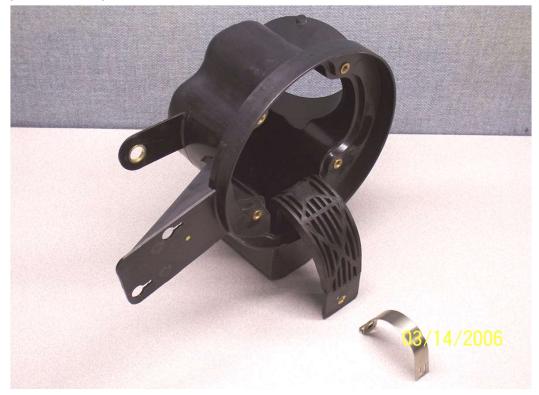
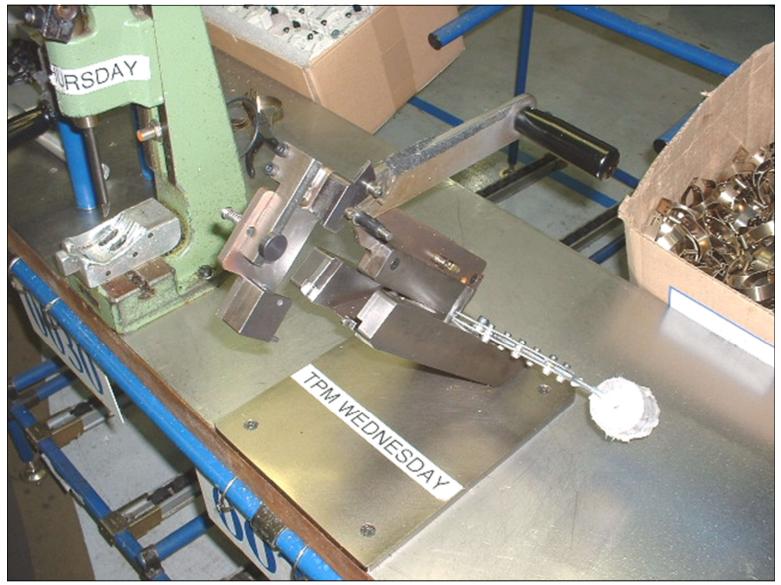
Using the methods of P-M Analysis I determined that the machine was of good design mechanically but simply was made of the wrong choice in grade of material - metal fatigue.

I had all the parts made from D-2 grade steel and hardened to Rockwell C70. I re-assembled it and as part of the TPM Autonomous Maintenance for Operators, I developed a TPM Lubrication and Bolting standard checklist - see inset. This completely eliminated the problem from mean time between failure of 5 days to infinity - to the day we stopped making the product.

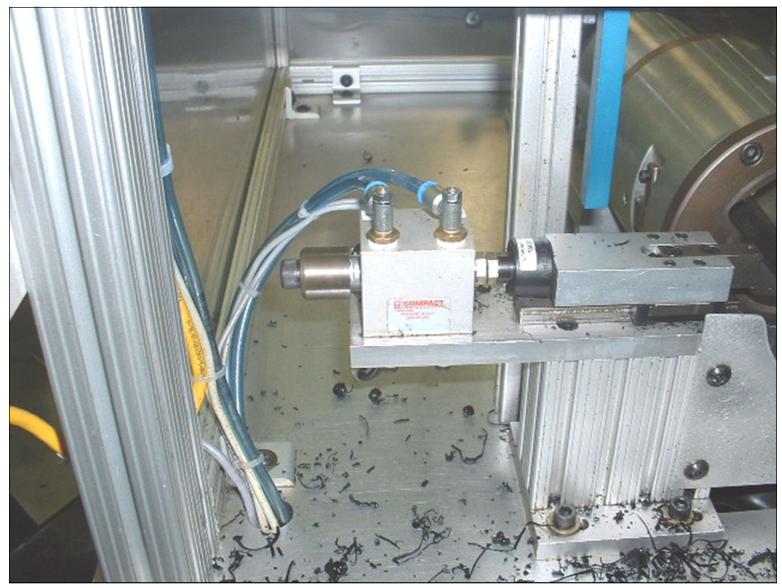
Problem here was a machine that was used to trim excess plastic from a flange of a gas filler nozzle neck for a well known luxury car manufacturer after a vulcanizing process.

The trim tool feed rate was very difficult to control the air cylinder extension speed resulting in jams and tool and product damage. I solved this problem by adopting an air-over-oil configuration using an another identical air cylinder mounted and connected to the through piston rod of the air feed cylinder.

The additional cylinder I filled with hydraulic oil and looped the extension and retraction ports with air hose using compression fillings to prevent leaks. I had to make a new longer mounting bracket too.

This modification allowed the speed of the extending tool to cut and trim into the product surface with a much improved uniform feed rate and far greater rigidity, no 'bouncing' of the cutting tool.

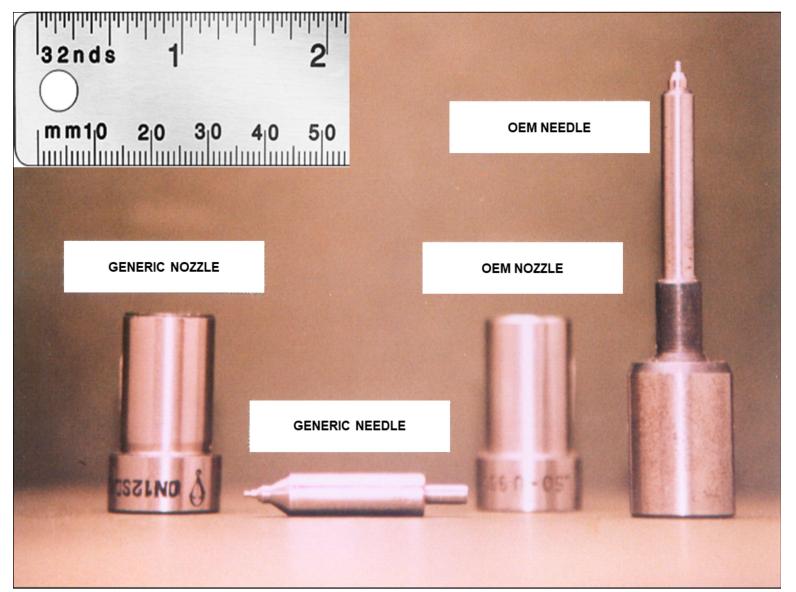
Another illustration of my intellectual capacity to apprehend, conceive, and implement cost saving contrivances and my engineering prowess. What you are looking at are metering needles and nozzles for a reaction impingement foam molding machine for a polyurethane and isocyanate mixing head.

Because of the high pressure - 3000 thousand psi or more - the immense energy generated by the two chemicals passing through an orifice that could be .7 mm Ø these two components had a definite useful life cycle of about a week before they were worn out and had to be replaced.

The cost of the original equipment manufacturer's needle and nozzle was \$280 dollars a set - see right side in picture - so the annual maintenance of replacement needles and nozzles alone for this RIM machine was \$27,000.00 dollars a year based on 49 weeks production calendar.

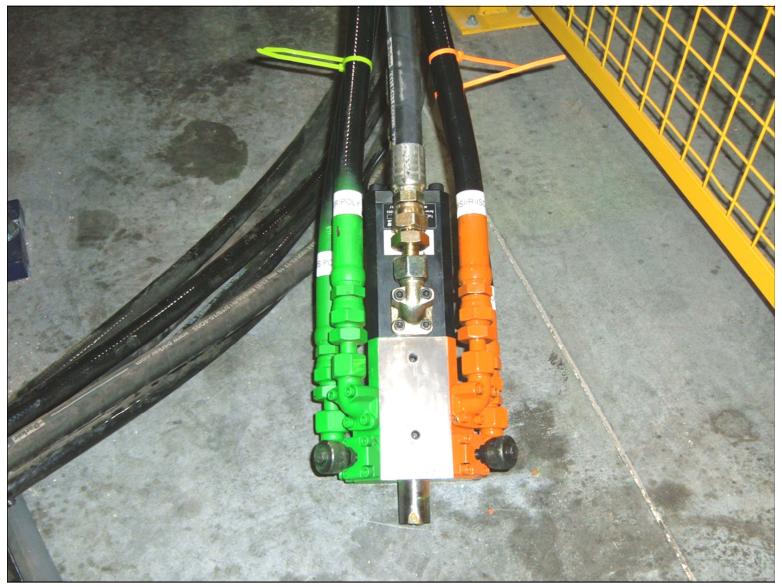
This pictures shows the high impingement mixing head from the previous slide. Quite possibly the one thing you did not want happen by any act of human omission, slip, lapse or violation with this process is crossing feed and return lines of the polyurethane and isocyanate with one another. The consequences of that failure mode are very, very expensive. We're talking hundred of thousands of dollars \$\$\$\$ replacing lines, hoses, pumps, storage vessels etc....

The baka-yoke approach here to make it physically impossible to make a mistake of screwing the isocyanate feed line hose onto the polyurethane line hose or any other combination you can think of except the right way was too expensive. It would have meant replacing all the lines on all the machines on all the mixing heads with left and right hand threaded hydraulic fittings.

So, the next best thing is poke-yoke, I color coded the fittings and hose lines and the isocyanate and polyurethane sides of the mixing head to serve as a warning that a mistake could be made - I did this spray painting all 25 machines mixing heads and lines. Continued on next page.

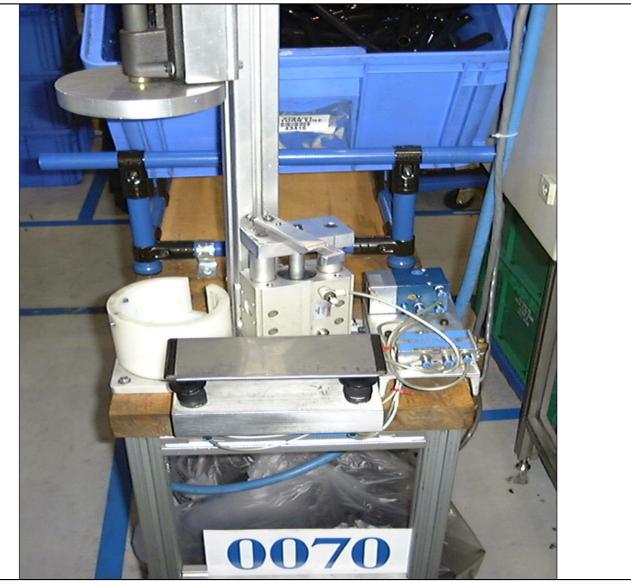
This picture shows a simple machine that was used to install an electrical circuit harness plug into the receptacle of gas tank level sender unit flange at a former employer.

This was of a very inferior design, poorly constructed and simply didn't work. The operators typically installed the harness plug into the receptacle by their hands and that was very hard on their hands and fingers. I later learned that \$5,000.00 was paid to a local engineering company to design, build and install this unreliable machine.

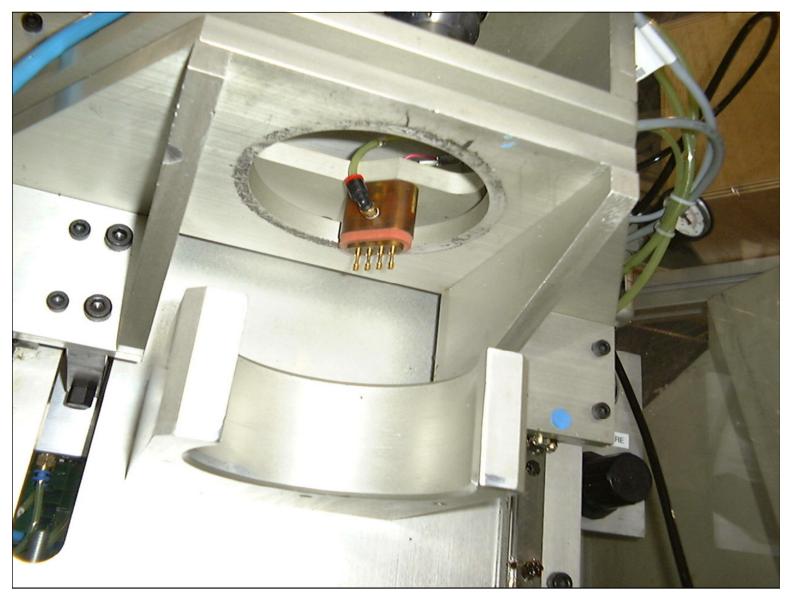
Picture showing an electrical spring loaded contact test probes assembly. The service life of these test probes should have been in the high 10 million cycle range, but were lasting only a fraction of that life time cycle.

Because the test probes were gold plated they were expensive \$20.00 each X 4 \$80.00 and had to be changed out on average 4 times a month. Do the math...

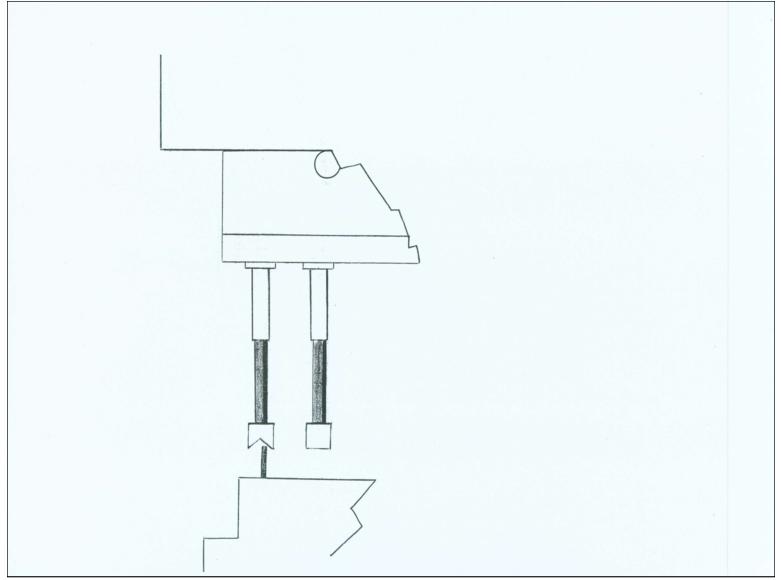
Using the P-M Analysis approach I set about to investigate this chronic problem. The original test probes were of a concaved head - see left sectioned test probe in illustration. During testing the part to be tested would be inserted into the test machine tool nest and the test probes would come into contact with the part's recessed socket contact terminals by way of pneumatic actuation of a mechanical fixture.

During my survey I observed that the recessed socket contact terminals did not always align itself exactly centered to the concaved test probes causing lateral stress on the inside surfaces of the spring loaded test probes. This mechanical misalignment was what was causing the accelerated deterioration and shortened life cycle of the test probes - eventually the failure mode was either breakage of the test probe or high internal contact surface electrical resistance resulting in false high resistance testing results - I tried to improve the repeat and reproducibility of the alignment of the test probe to recessed socket contact terminals, but this only resulted in an improvement of 50%.

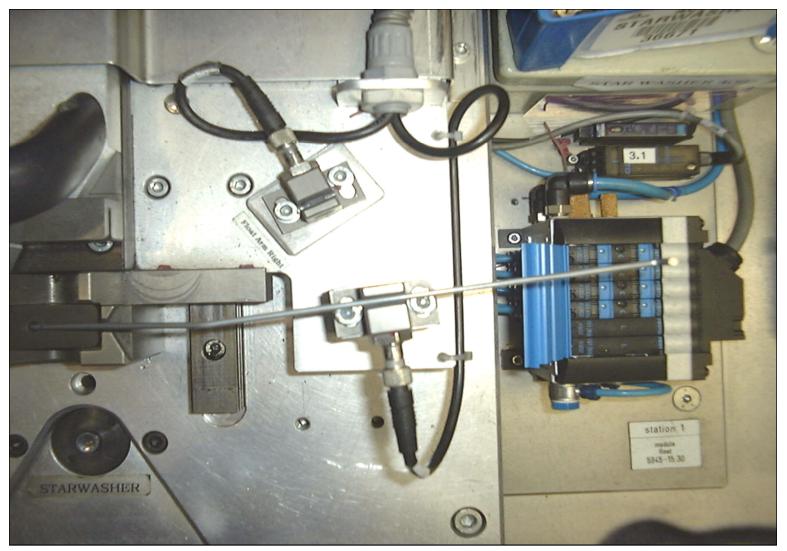
Minor stoppages and idling account for much downtime which go unrecorded. Pictured is an assembly machine that is used to assemble a star waster retainer on to a gas tank level sender unit float arm. Part of the mistake proofing the process (Poke-Yoke) was present/absent component detectors and in this case proximately sensors were used to detect that the correct float arm was being used for the part type being made.

The operator of the machine occasionally would snag the cables to these proximately sensors breaking them from their electrical couplers. When this happened the entire cable had to be changed out. Asking the operator to be more careful does not fix a faulty process, so I installed mechanical protection shields to protect the cables from the operator accidentally snagging the float arms on them.
