SIX SIGMA PROJECT CHARTER - DEFINE

PROJECT TITLE 2300C PRODUCTION LINE SCRAP REDUCTION & SECONDARY EQUIPMENT RELIABILITY IMPROVEMENT

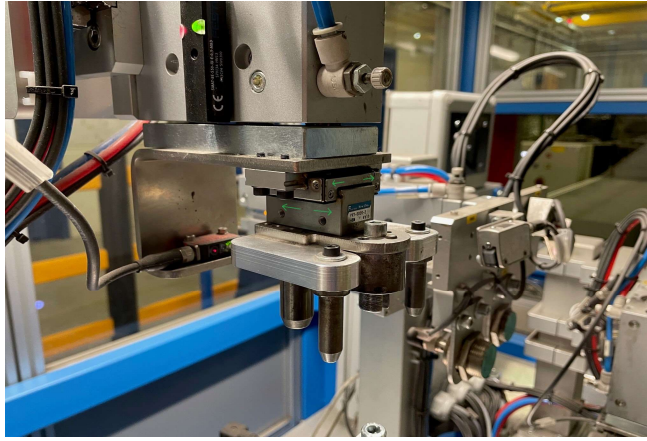
| PICTURE 16.05 | PICTURE 16.06 | PICTURE 16.07 | PICTURE 16.08 | |

| 16.00 EXTEND ALIGNMENT 'FORKS' ON VS30 NUMBER 3 BUSHING FIXTURE FOR EOLT 3017195-0080 - Currently there is very little alignment of the bushing to the mounting leg hole before bushing is pressed in | | | | |

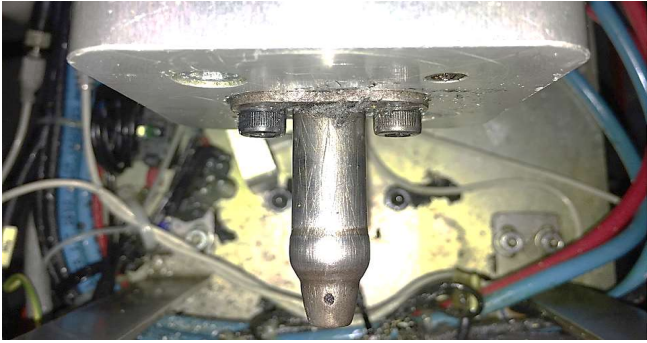
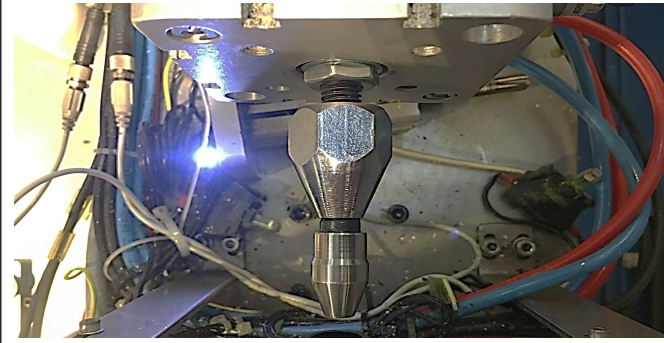
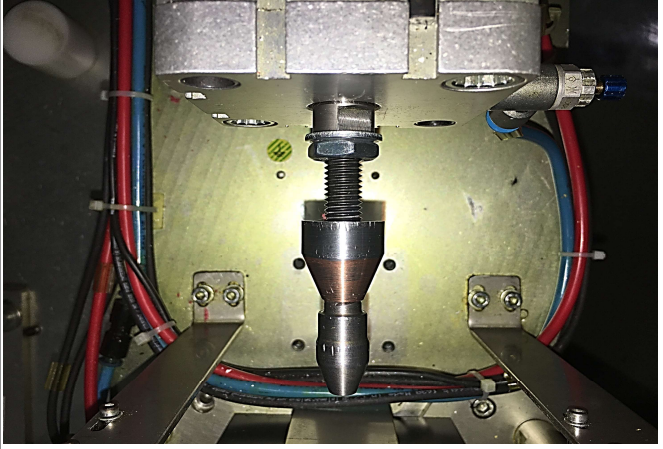
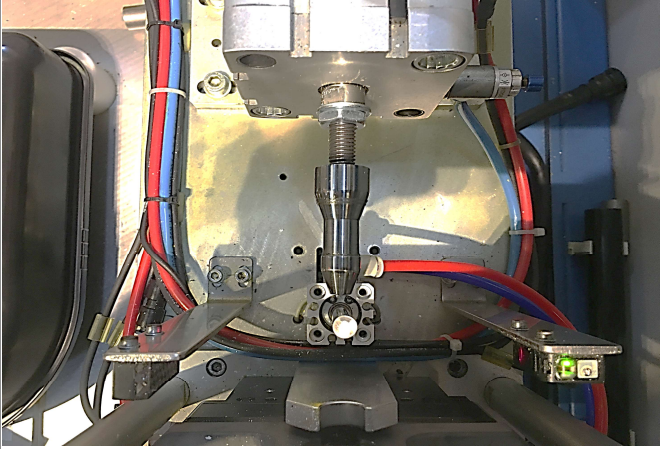
| PICTURE 19.01 | PICTURE 19.02 | PICTURE 19.03 | PICTURE 19.04 | |

| 19.00 MODIFY THE FLARING TOOL ON 0020-3017194 - This has been a long standing problem. of the vent pipe not being flared to allow to come into alignment the SCR tank barb fitting during installaton. The idea here is to make and install a conical flaring tool to flare the end of pipe. | | | | |
| FLARING TOOL OLD - BEFORE | FLARING TOOL NEW - AFTER | FLARING TOOL NEW - AFTER VERSION 2 | FLARING TOOL NEW - FINAL VERSION 3 | |

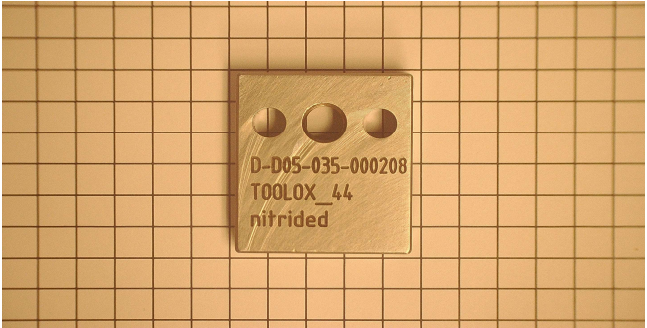
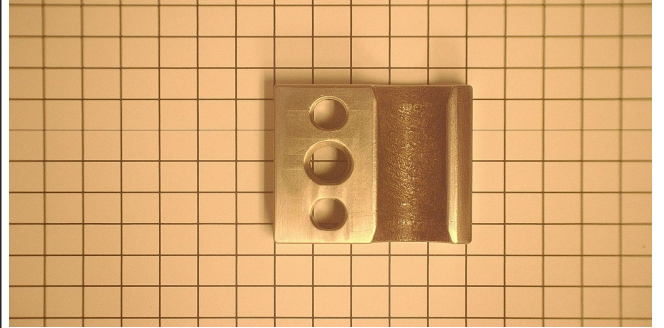
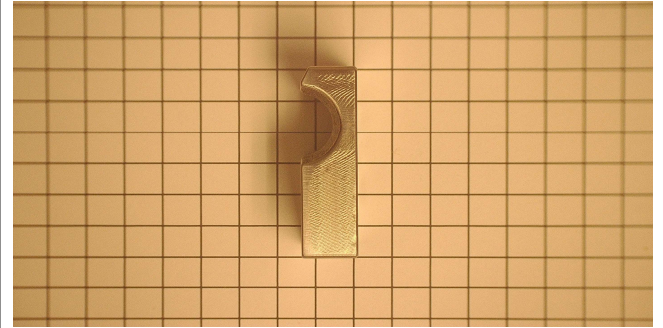
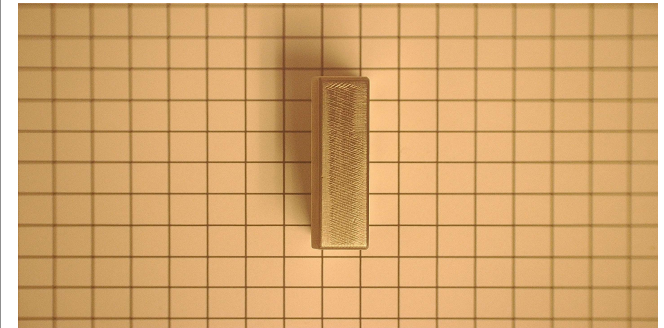
| PICTURE 20.10 | PICTURE 20.02 | PICTURE 20.03 | PICTURE 20.04 | |

| 20.00 REPLACE WORN OUT ASSEMBY 2 VENT PIPE GRIPPER TOOL - Currently we are gluing sand paper to the gripper tools because there is insufficient friction force between the inner contact surface of the vent hose gripper tools and the outside surface wall of the vent | | | | |

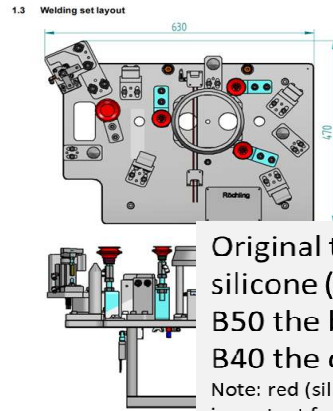
PICTURE 25.01

25.00 REPLACE MRO OR TYPE SUCTION CUPS BEING SUBSTITUTED FOR ALL PART TYPES FIXTURES - I have found that many of the suction cups used in the fixtures for the different part types used in this machine have been replaced with incorrect non-standard non-original suction cups with a mixture

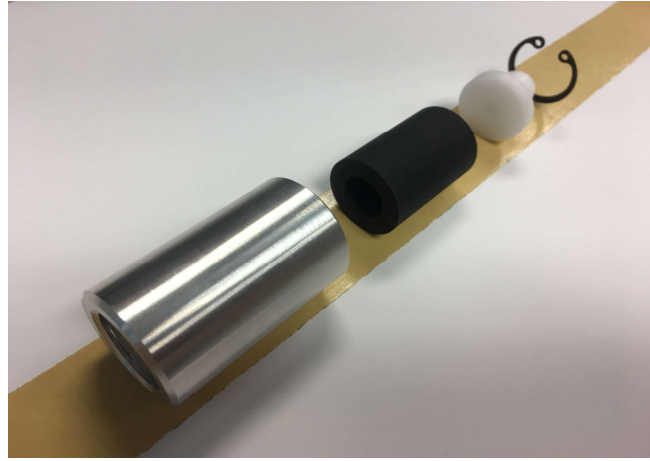
PICTURE 26.01

26.00 MBUSI VS30 SCR TANT HELIUM LEAK TEST ALUMINUM TEST CAP PLUG AND RUBBER INSERTS RENEW - Worn out and or missing need X4 aluminum cap and X24 rubber insert bungs

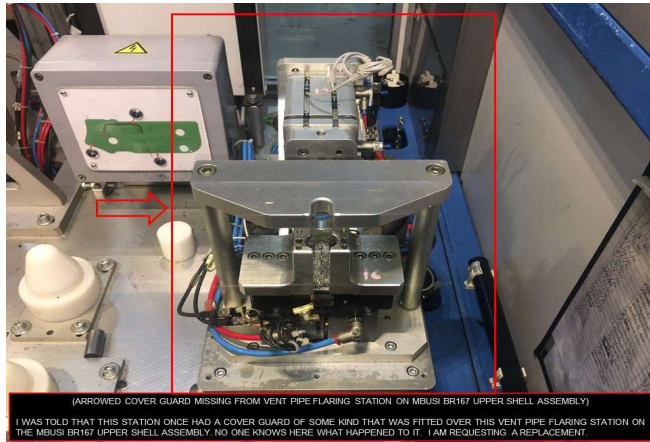
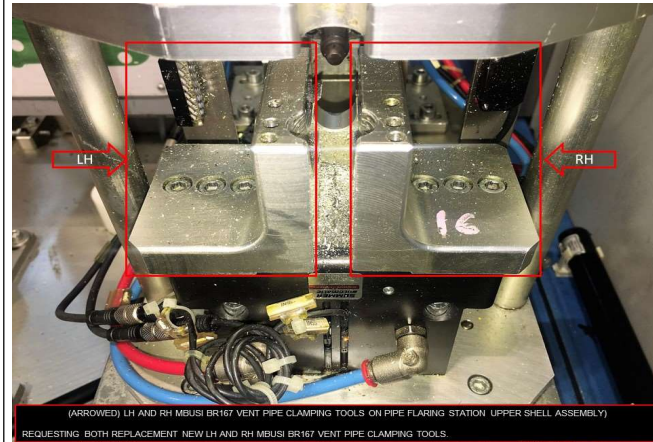
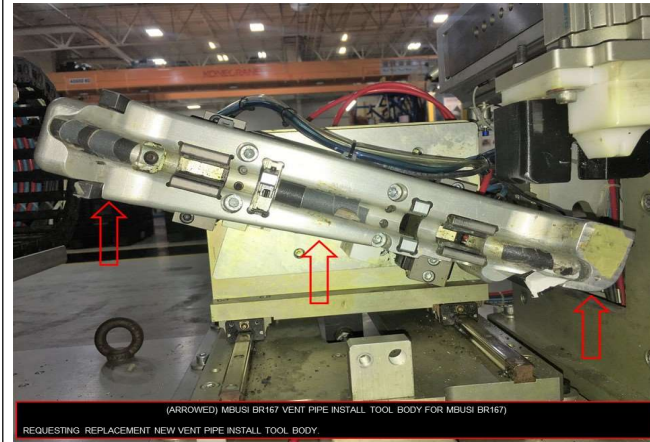
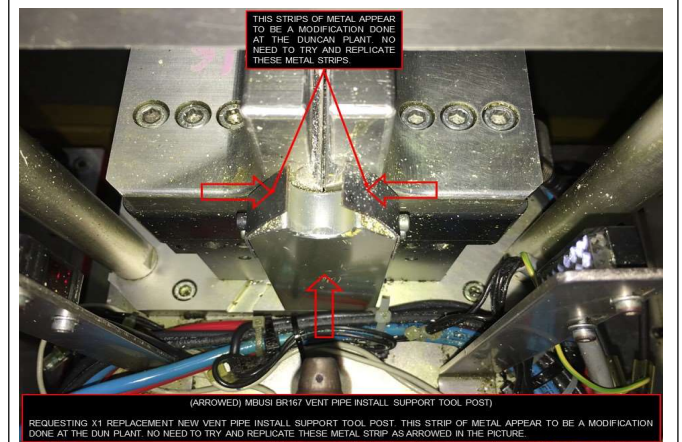
27.00 REPLACE ALL WORN TOOLING ON BR167 UPPER SHELL ASSEMBLY - Most of the tooling to tooling and part to tooling fixture are worn out and or broken and need to be replaced.

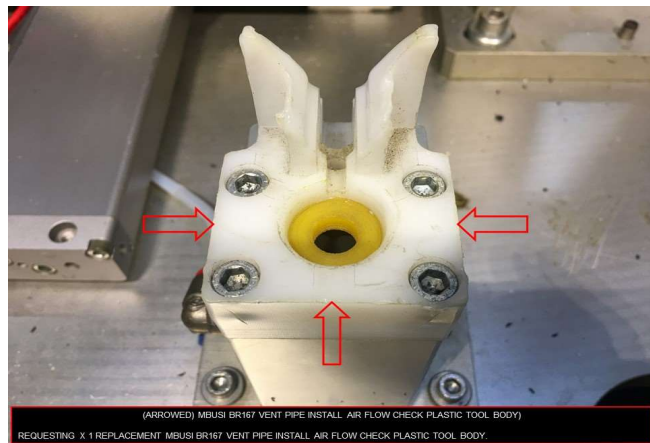
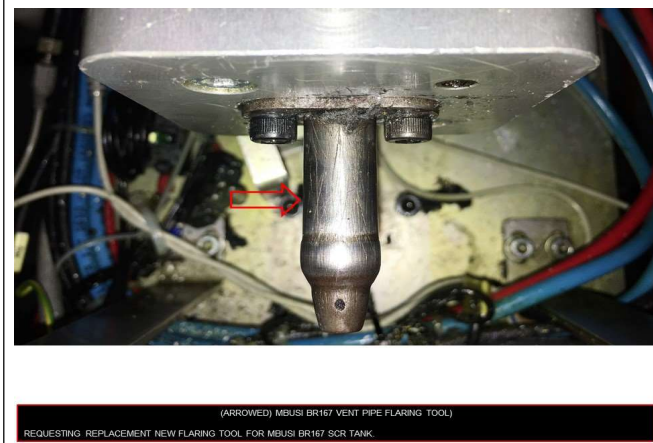
28.00 REPLACE ALL WORN TOOLING ON BR167 UPPER SHELL ASSEMBLY - Most of the tooling to tooling and part to tooling fixture are worn out and or broken and need to be replaced.

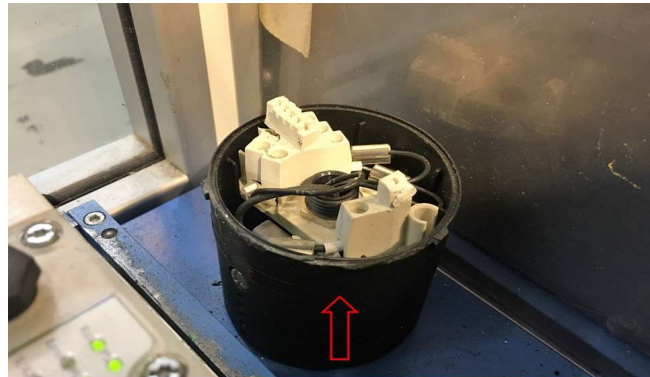
PICTURE 29.01

29.00 REPLACE BROKEN MISSING TOWEL STATUS LIGHT TOWLER ON UPPER SHELL ASSEMBLY 3017194 - This is necessary so the operator if visually alerted if the part is good (green light) or bad (red light).

(ARROWED) 0220-1730194-2016-155 UPPER SHELL ASSEMBLY STACK LIGHT TOWER)
 REQUESTING TWO (2) REPLACEMENT STACK LIGHT TOWERS. THERE ARE TWO MOUNTED INSIDE THE MACHINE ON BOTH SIDES. BOTH ARE DAMAGED AND I WAS UNABLE TO DETERMINE THE MANUFACTURER'S NAME OR ANY DETAILS ABOUT HOW MANY LIGHTS AND COLORS WERE ON THE STACK TOWER. I HOPE MAYBE YOU HAVE A RECORD OF WHAT YOU INSTALLED ON HERE.

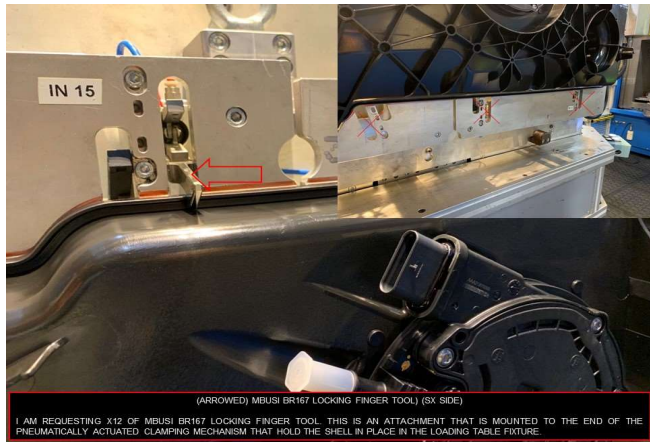
PICTURE 30.01

30.00 3017193 SHELL TO SHELL WELDER REPLACE BROKEN OR MISSING LOCKING PAWLS, CABLE CLIPS 3017194 - A lot of the locking hooks are missing and broken on the loading table fixtures for both VS30 and BR167

(ARROWED) MBUSI BR167 LOCKING FINGER TOOL (SX SIDE)
 I AM REQUESTING X12 OF MBUSI BR167 LOCKING FINGER TOOL. THIS IS AN ATTACHMENT THAT IS MOUNTED TO THE END OF THE PNEUMATICALLY ACTUATED CLAMPING MECHANISM THAT HOLD THE SHELL IN PLACE IN THE LOADING TABLE FIXTURE.

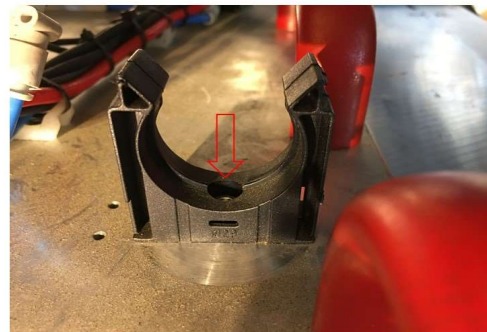
PICTURE 30.02

(ARROWED) PLASTIC FLEX CORRUGATED ELECT. CABLE PNEU. TUBE LOOM MOUNTING CLIP - 29 MM (DX SIDE)
 I AM REQUESTING X12 OF THESE MOUNTING CLIPS OR CLAMPS USED FOR SECURING FLEXIBLE CORRUGATED PLASTIC LOOM CONDUIT. IT DOES NOT HAVE THE MANUFACTURER NAME MARKED ON ANY WHERE BUT THE DIAMETER IS MARKED AS Ø 29. WHAT IS MISSING IS THE TOP PART OF THE CLAMP THAT HOLDS THE FLEX TUBE IN PLACE.

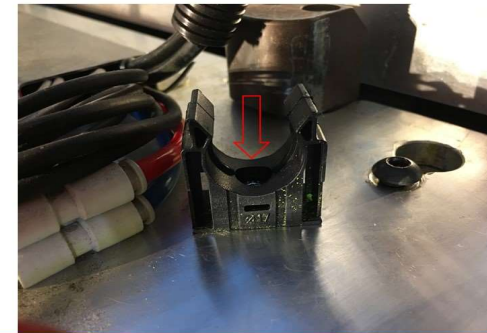
PICTURE 30.03

(ARROWED) PLASTIC FLEX CORRUGATED ELECT. CABLE PNEU. TUBE LOOM MOUNTING CLIP - 17 MM (DX SIDE)
 I AM REQUESTING X12 OF THESE MOUNTING CLIPS OR CLAMPS USED FOR SECURING FLEXIBLE CORRUGATED PLASTIC LOOM CONDUIT. IT DOES NOT HAVE THE MANUFACTURER NAME MARKED ON ANY WHERE BUT THE DIAMETER IS MARKED AS Ø 17. WHAT IS MISSING IS THE TOP PART OF THE CLAMP THAT HOLDS THE FLEX TUBE IN PLACE.

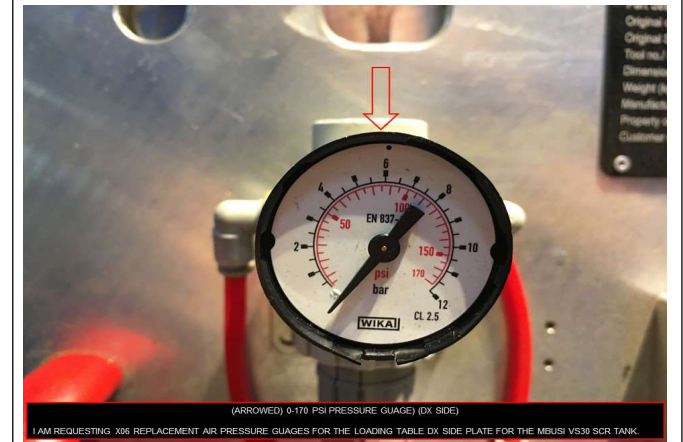
(ARROWED) 0-170 PSI PRESSURE GAUGE (DX SIDE)
 I AM REQUESTING X06 REPLACEMENT AIR PRESSURE GAUGES FOR THE LOADING TABLE DX SIDE PLATE FOR THE MBUSI VS30 SCR TANK.

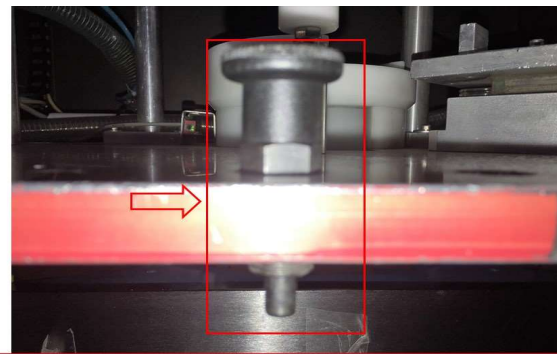
LOCATING LOCKING PLUNGER PINS

(ARROWED) HELIUM LEAK TESTER DETENT LOCATOR (SPRING LOADED PLUNGER PIN)
 I AM REQUESTING X4 REPLACEMENT HELIUM LEAK TESTER LOCATOR (SPRING LOADED PLUNGER PINS). THESE ARE MOUNTED ON EACH OF THE SLIDING FIXTURES FOR ALL THE SCR TANKS (SLIDING TABLES). THIS SPRING LOADED PLUNGER PIN IS PULLED UP BY THE OPERATOR. THE SLIDING TABLE FIXTURE IS SLID INTO THE TESTING CHAMBER AND THE PIN IS RELEASED LOCKING IT INTO THE DETENT LOCATOR TO HOLD THE FIXTURE TABLE IN PLACE DURING TESTING. AS THIS IS MOUNTED TO THE FIXTURE TABLE I AM CLASSIFYING THIS PART UNDER A FIXTURE. SPARE PART

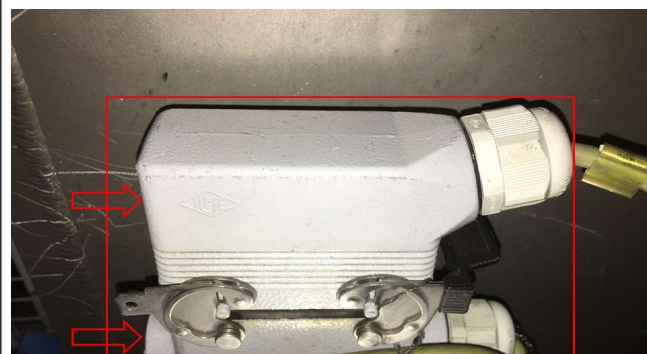
REPLACE ALL BROKEN PIN & SLEEVE CONNECTOR BLOCKS

(ARROWED) HELIUM LEAK TESTER MULTI PIN ELECTRICAL LATCHING CONNECTOR (PLUG AND RECEPTACLE)
 I AM REQUESTING X10 REPLACEMENT HELIUM LEAK TESTER MULTI PIN ELECTRICAL LATCHING CONNECTOR PLUGS. AS THIS CONNECTS THE ELECTRICS FROM THE FIXTURE TO THE MACHINE. I AM CLASSIFYING THIS PART UNDER A FIXTURE. SPARE PART. I CANNOT MAKE OUT WHO THE MANUFACTURER IS AND ALMOST CERTAINLY A EUROPEAN MADE. WHAT HAS HAPPENED TO MANY OF THE CONNECTORS IS THAT THE LATCHING CLIPS HAVE BROKEN MAKING DIFFICULT FOR THE OPERATOR TO LATCH THE CONNECTOR IN PLACE. I AM ONLY REQUESTING THE RECEPTACLES BUT IF IT HAS TO COME WITH THE PLUG, I WILL HAVE TO PURCHASE THOSE TOO AS A SET IF NEED BE.

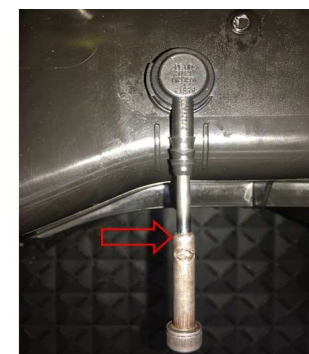
RESTORE ORIGINAL TAPER PLUG FOR VS30

(ARROWED) HELIUM LEAK TESTER MBUSI VS30 SCR TANK PLUG)
 I AM REQUESTING X6 REPLACEMENT HELIUM LEAK TESTER MBUSI VS30 SCR TANK TAPER PLUG. THIS PLUG IS USED TO PLUG OR BLANK OFF THE SO CALLED "VALVE" LOW FLOW WITH MEMBRANE DURING HELIUM LEAK TESTING. I AM SURE THIS M6 X 45 MM ALLEN CAP SCREW THAT LOOKS LIKE IT HAS BEEN TURNED DOWN ON THE END FOR A MAKE SHIT PLUG CAN NOT BE THE ORIGINAL DESIGN. PLEASE COULD YOU CHECK YOUR RECORDS OF WHAT THE ORIGINAL DESIGN WAS AND SEND THOSE TO ME.

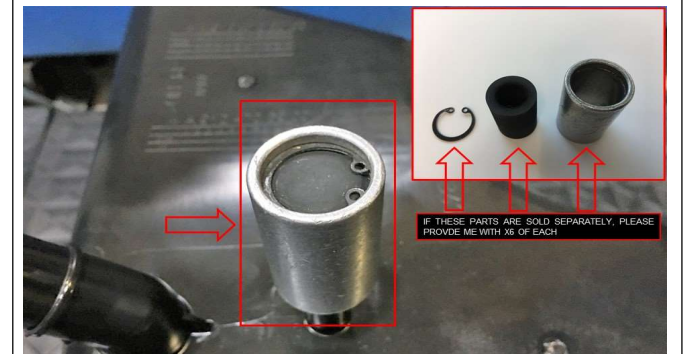
REPLACE ALLUMINUM RUBBER INSERT PLUG BUNG VS30

(ARROWED) HELIUM LEAK TESTER MBUSI VS30 SCR TANK CAP (PLUG)
 I AM REQUESTING X6 REPLACEMENT HELIUM LEAK TESTER MBUSI VS30 SCR TANK CAP (PLUG). THIS PLUG IS USED TO PLUG OR BLANK OFF A BARB FITTING ON THE SCR TANK DURING HELIUM LEAK TESTING. IF THIS IS A THREE (3) PART COMPONENT OF THE ALUMINUM CAP, SNAP RING (CIRCLIP) AND RUBBER PLUG OR BUNG PLUG THEN I WOULD LIKE TO HAVE SIX (6) OF EACH.

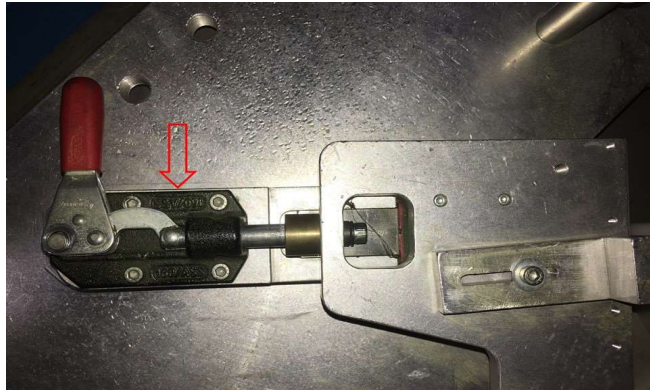
REPLACE LH AND RH PUMP CAP SEAL CLAMP

(ARROWED) HELIUM LEAK TESTER MBUSI VS30 SCR TANK TOGGLE CLAMP
I AM REQUESTING X4 REPLACEMENT HELIUM LEAK TESTER MBUSI VS30 SCR TANK TOGGLE CLAMP. THIS TOGGLE CLAMP IS USED TO SECURE THE SCR IN PLACE DURING HELIUM LEAK TESTING.

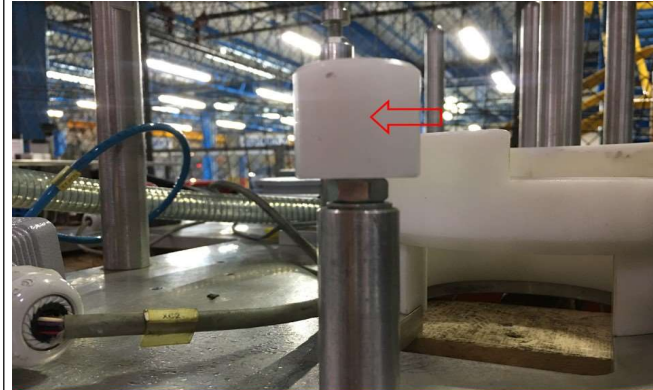
REPLACE SUPPORT POST FOR VS30 FIXTURE

(ARROWED) HELIUM LEAK TESTER MBUSI VS30 SCR TANK NYLON SUPPORT POST
I AM REQUESTING X8 REPLACEMENT HELIUM LEAK TESTER MBUSI VS30 SCR TANK NYLON SUPPORT POST. THE BOTTOM OF THE SCR TANK ON TWO THESE NYLON SUPPORT POST SOME ARE MISSING OR BROKEN, REQUESTING THE NYLON POST ONLY.

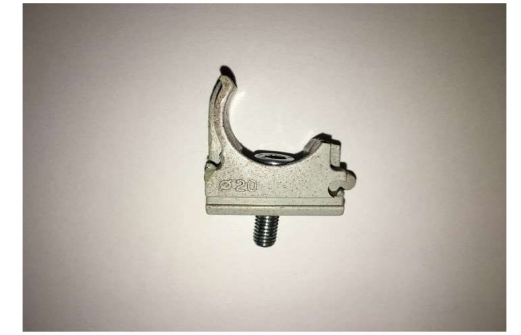
(ARROWED) BMW G95/G96/G97 SCR TANK HELIUM LEAK TESTER FIXTURE. PLASTIC CONDUIT SNAP IN PLACE CLAMP
I AM REQUESTING X12 REPLACEMENT PLASTIC CONDUIT SNAP IN PLACE CLAMPS. I AM USING THE FIXTURE REFERENCE AS A GUIDE FOR YOU TO IDENTIFY WHICH MANUFACTURER OF CLAMP YOU USED FOR THIS FIXTURE. THERE IS NO MANUFACTURER MARKED ON IT BUT THE SPEC IS AS FOLLOWS:

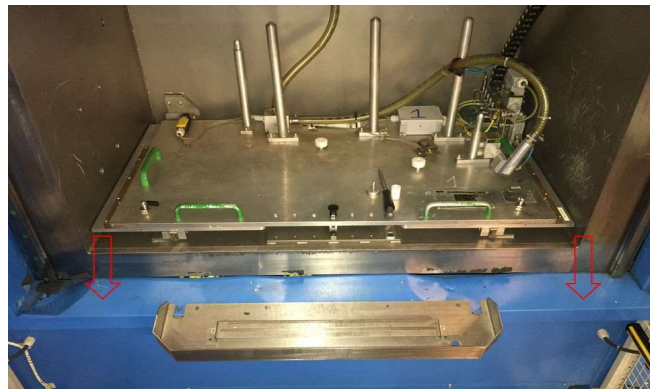
(ARROWED) HELIUM LEAK TESTER FRONT MACHINE FRAME COVER GUARD
I AM REQUESTING X2 REPLACEMENT HELIUM LEAK TESTER MACHINE FRAME COVER GUARDS. THE ORIGINALS HAVE BECOME DAMAGED BY THE CARELESS PLACING OF OBJECTS ON THE SURFACE IN WHICH THE CHAMBER DOOR CRUSHES DOWN UPON.

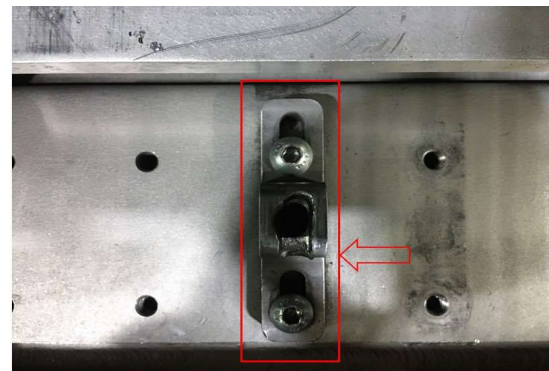
(ARROWED) HELIUM LEAK TESTER DETENT LOCATOR FOR LOCKING IN POSITION SLIDING TABLE
I AM REQUESTING X4 REPLACEMENT HELIUM LEAK TESTER DETENT LOCATOR TOOL FIXTURE FOR LOCKING IN PLACE INSIDE OF HELIUM TESTER CHAMBER SLIDING TABLE FIXTURE. THIS IS A LOCATOR FOR THE SPRING LOADED PIN PLUNGER FOR HOLDING THE SLIDING FIXTURE TABLE INSIDE THE CHAMBER DURING TESTING. ALTHOUGH MBUSI VS30 SCR TANK WAS RUNNING AT THE TIME THAT I TOOK THIS PICTURE THIS IS MOUNTED TO THE MACHINE ITSELF SO I AM CLASSIFYING THIS PART UNDER A MACHINE SPARE PART.

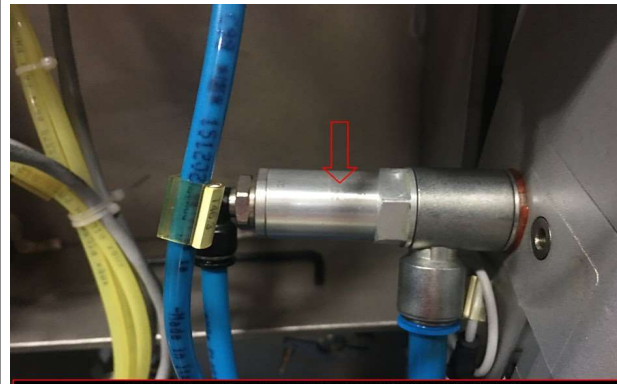
(ARROWED) HELIUM LEAK TESTER DOOR AIR CYLINDER PILOT CONTROLLED CHECK VALVE
I AM REQUESTING X4 PILOT CONTROLLED CHECK VALVES OR AIR CYLINDER CONTROL VALVES. THESE ARE MADE BY FESTO AND THE PART NUMBER IS HCL-12-05-12 (330949)

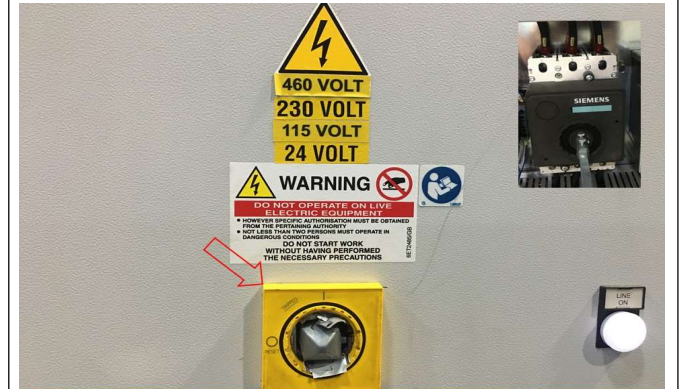
(ARROWED) HELIUM LEAK TESTER MAIN ELECTRICAL PANEL DISCONNECTOR LEVER
I AM REQUESTING X1 MAIN ELECTRICAL CONTROL PANEL DISCONNECTOR LEVER. IF THIS MEANS HAVING TO PURCHASE THE WHOLE SWITCHGEAR MECHANISM SO BE IT.

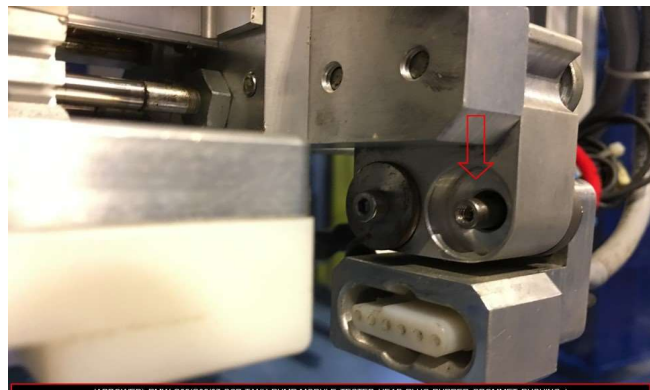
(ARROWED) BMW G95/G96/G97 SCR TANK PUMP MODULE TESTER HEAD PLUG RUBBER GROMMET BUSHING
I AM REQUESTING X12 BMW G95/G96/G97 SCR TANK PUMP MODULE TESTER HEAD PLUG RUBBER GROMMET BUSHINGS. IN THE PICTURE THE GROMMET BUSHING IS MISSING AND I AM RELYING ON YOUR RECORD KEEPING AS TO WHAT TYPE OF RUBBER BUSHING YOU USED FOR THIS AND IT DIMENSIONS.

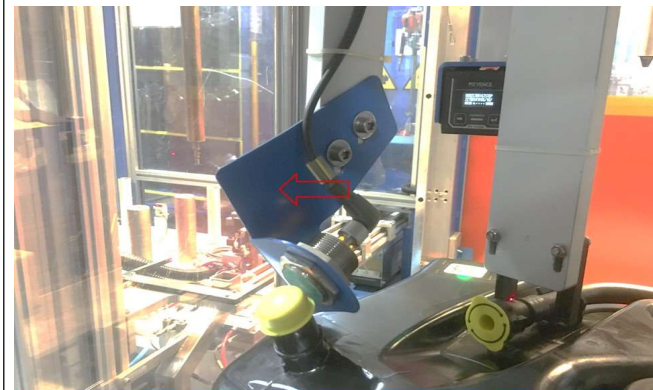
(ARROWED) MBUSI BR167 SCR TANK FILLER NECK INSERT SLEEVE PROXIMITY SENSOR MOUNTING BRACKET
I AM REQUESTING X2 FILLER NECK INSERT SLEEVE PROXIMITY SENSOR MOUNTING BRACKET FOR THE DAMLER BR167 FIXTURE FOR THE END OF LINE TESTER.

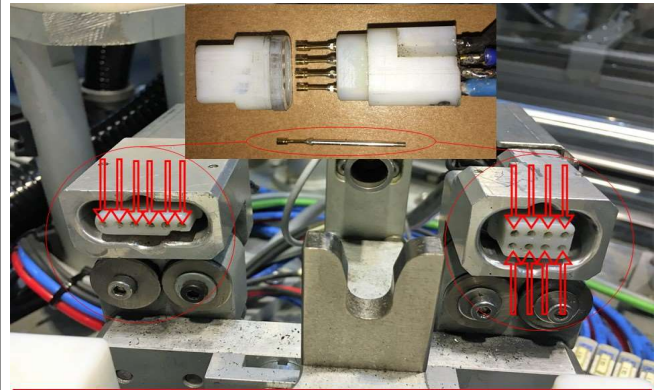
TEST PROBE BLOCKS AND TEST PROBES

(ARROWED) MBUSI BR167 END OF LINE TESTER TEST HEAD SPRING-LOADED SCREW-IN TEST PROBES
REQUESTING X48 REPLACEMENT TEST HEAD SPRING LOADED SCREW-IN TEST PROBES. TO ILLUSTRATE I HAVE IMPOSED A PICTURE OF TEST BLOCK 2 SPRING-LOADED SCREW-IN TEST PROBE. THE TEST PROBE HEAD TYPE IS BERRATED.

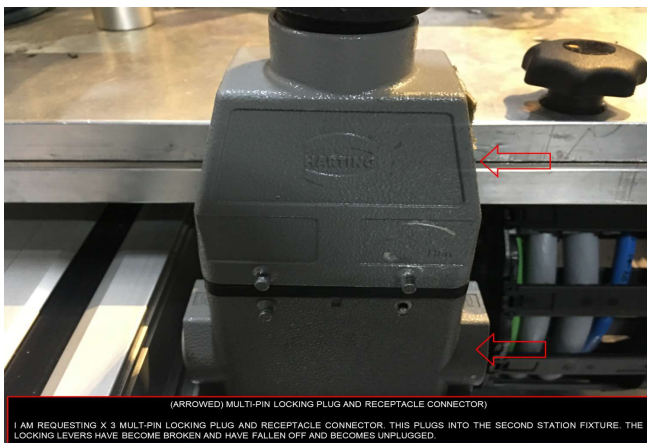
(ARROWED) MULTI-PIN LOCKING PLUG AND RECEPTACLE CONNECTOR
 I AM REQUESTING X 3 MULTI-PIN LOCKING PLUG AND RECEPTACLE CONNECTOR. THIS PLUGS INTO THE SECOND STATION FIXTURE. THE LOCKING LEVERS HAVE BECOME BROKEN AND HAVE FALLEN OFF AND BECOMES UNPLUGGED.
