MAINTENANCE BULLETIN S-MN-GEN-7XX

Erema Incline Belt Conveyor Roller Modification v1

1.1. This document describes and details the modification/s and requisite task/s instructions in original equipment manufacturer design in the SC1 Erema recycling machine incline belt conveyor deflection roller at the Fitesa, Simpsonville plant, SC.

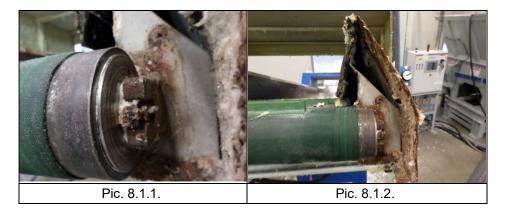
**8.1.** From commission 01/08/2010 The Erema deflector roller has failed X 5 times. By definition failed means that the roller is unable to rotate. MTBF = 12 months The main reason is that the bearings for the roller have seized thus preventing the idler shaft of the roller to rotate freely. Servicing the bearings in the ends of the roller is difficult as the roller has to be completely removed from in situ, partially dismantled and then greased and re-assembled. Pics. 8.1.1. and 8.1.2.

9.1. Following a physical analysis it was determined that there was insufficient sealing of the end which allowed steam to enter the inside of the roller cavity contact the internally fitted spherical bearing enter the bearing and wash out the lubrication grease and leave the bearing unlubricated which accelerated it deterioration to the point of functional failure.

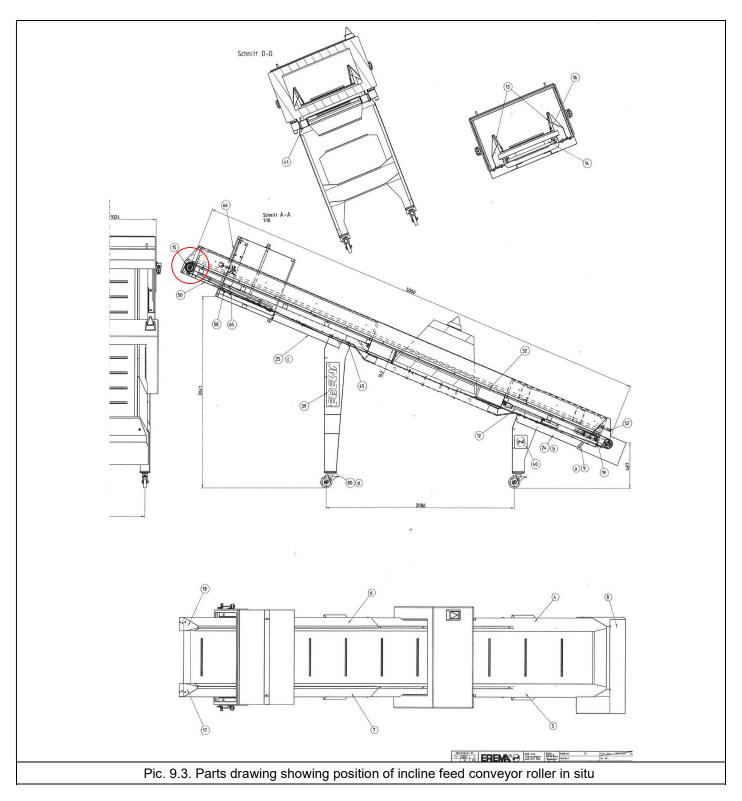
- **9.3.** Picture 9.3. Demonstrates the arrangement of the roller in situ with the incline feed conveyor.
- **9.4.** It was determined by the author that modification to the OEM design of the roller was requisite in order to achieve a longer mean time between failure of the roller bearings and ease of maintenance access to achieve the afore.

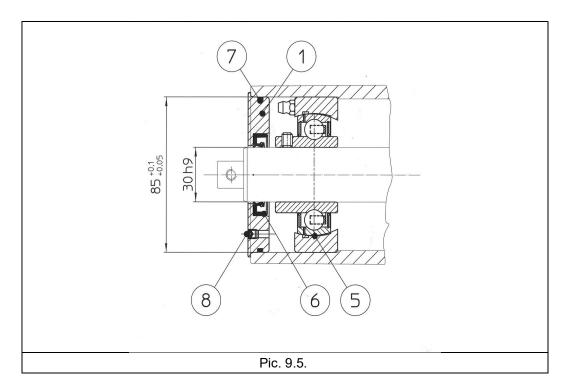
**9.5.** Picture 9.5. showing the original equipment manufacturer bearing installation method.

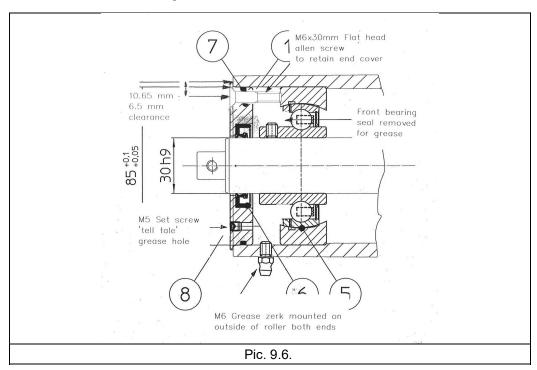
**9.6.** Picture 9.6. showing the modifications to the roller

9.7. The modifications to the roller and end covers included the drilling and counter-sinking a6.5 mm clearance hole aligning with the M6 grease access port to the spherical bearing housing Pic. 9.7.1.. This was to retain the end cover to prevent it from being pushed out

during greasing – detailed below. The other modification was to remove the front bearing seal and then fill the area inside the end of the roller with grease.
