Document Title: MAINTENANCE BULLETIN S-MN-GEN-7352

Simpsonville, South Carolina	
Erema Incline Belt Conveyor Roller Modification v1				
Document Number: S-MN-GEN-7352	Rev No: 01	Date: 05/05/14	Document Owner: Reliability & CI Manager	Approvers: Maintenance Manager

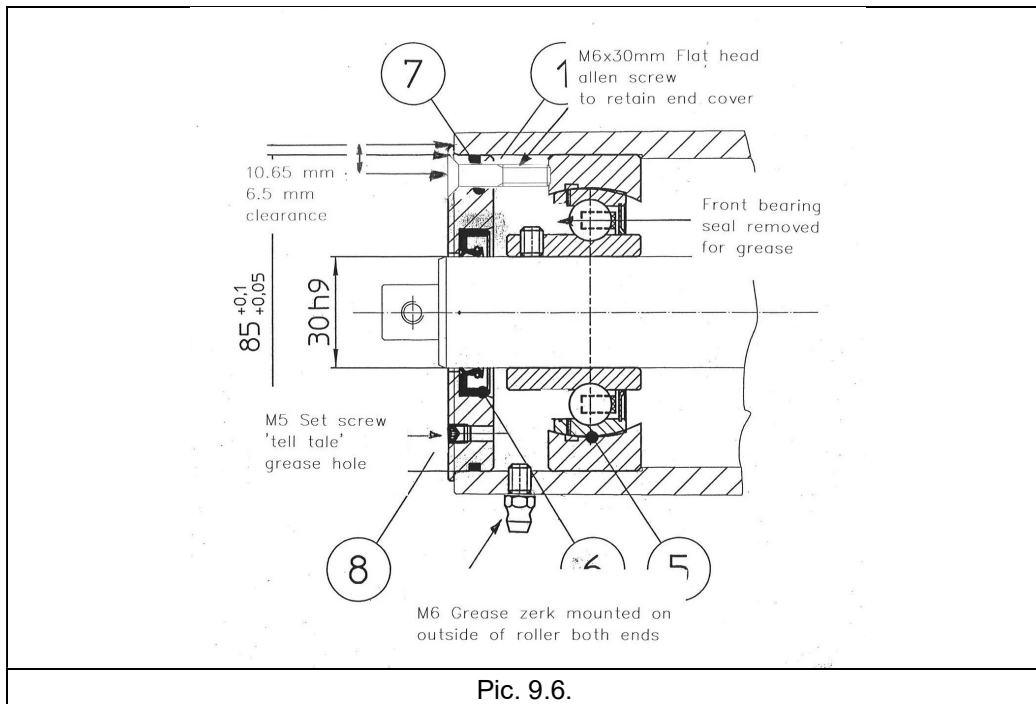
Pic. 9.6.

9.6. Picture 9.6. showing the modifications to the roller

9.7. The modifications to the roller and end covers included the drilling and counter-sinking a 6.5 mm clearance hole aligning with the M6 grease access port to the spherical bearing housing Pic. 9.7.1.. This was to retain the end cover to prevent it from being pushed out

during greasing – detailed below. The other modification was to remove the front bearing seal and then fill the area inside the end of the roller with grease.

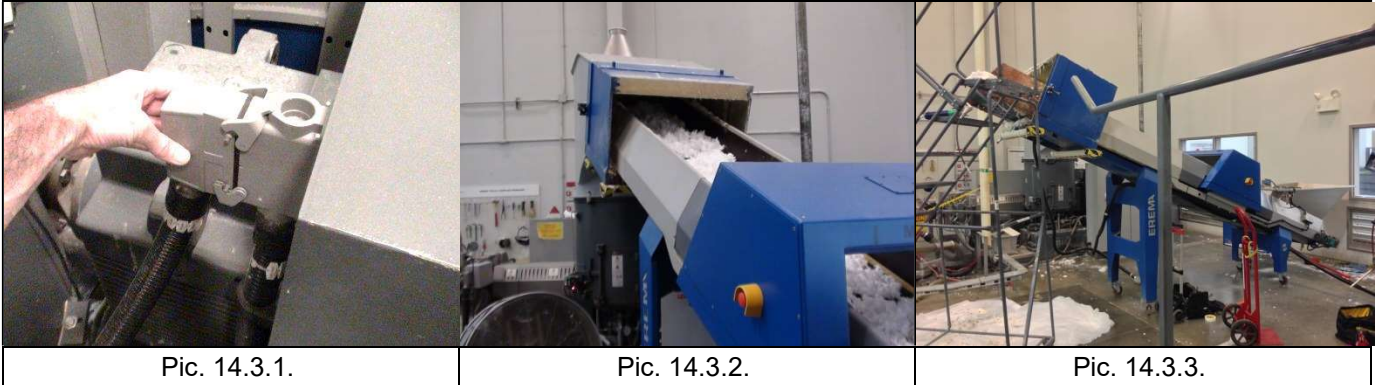
14.3. Unlock the conveyor caster wheels. Unclamp and unplug the electrical control socket plug Pic. 14.3.1. Push back the incline belt feed conveyor from the cutter compactor hood Pic. 14.3.2. Rotate to the left sufficiently that you are able to gain access to the top end of the conveyor Pic. 14.3.3.

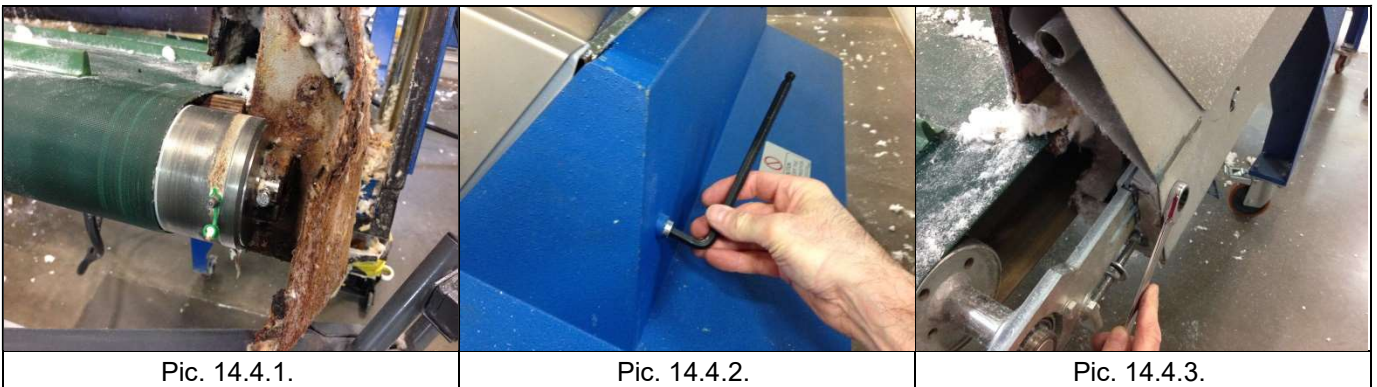
14.4. If the grease zerk is not positioned as shown in Pic. 14.4.1. Plug the electrical control socket plug back in, remove lockout/tagout, restore power to the Erema machine and have someone turn on the incline conveyor while another person watches the belt and stop the belt when the grease zerk has rotated to the position as shown in Pic. 14.4.1. If restoring power is not possible you will have to rotate the roller manually. Remove the drive guard by removing the X 2 M8 cap head bolts Pic. 14.4.2. Remove the guard and set aside. Loosen the belt tensioner locking clamps on both sides of the conveyor Pics. 14.4.3 and 14.4.4. Loosen the belt tensioner/tracking adjusting nuts on both sides of the conveyor by about 1" Pics. 14.4.5. and 14.4.6. If necessary tap the ends of the belt tensioner/tracking brackets in using the 11.5 lbs plastic mallet. Pic. 14.4.7. This should provide you enough slack in the belt to allow you to rotate the roller to the position where you can access the grease zerk and 'fill-hole' Pic. 14.4.8.

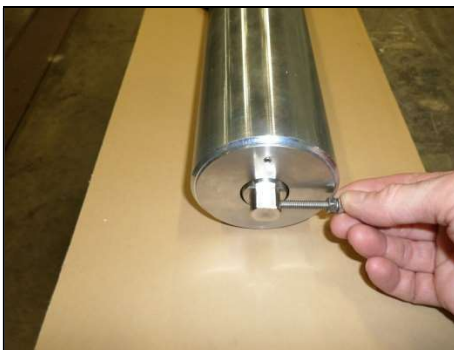
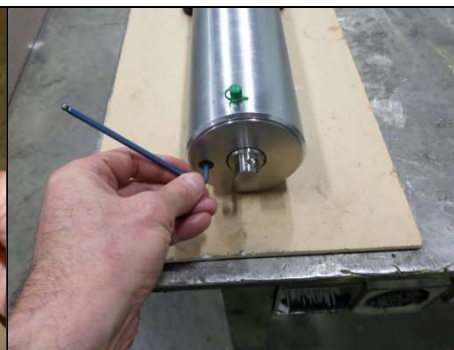
Pic. 14.8.1.

- 15.7. Loosen the M6 shaft jack screw jamb nuts. Unscrew and remove the M6 shaft jack screws on both ends of the shaft Pic. 14.8.1.. Unscrew and remove the M6 X 30 mm Allen flat head cap screw Pic. 14.8.2.. Unscrew and remove the M5 set screw from the 'fill-hole' Pic. 14.8.3.

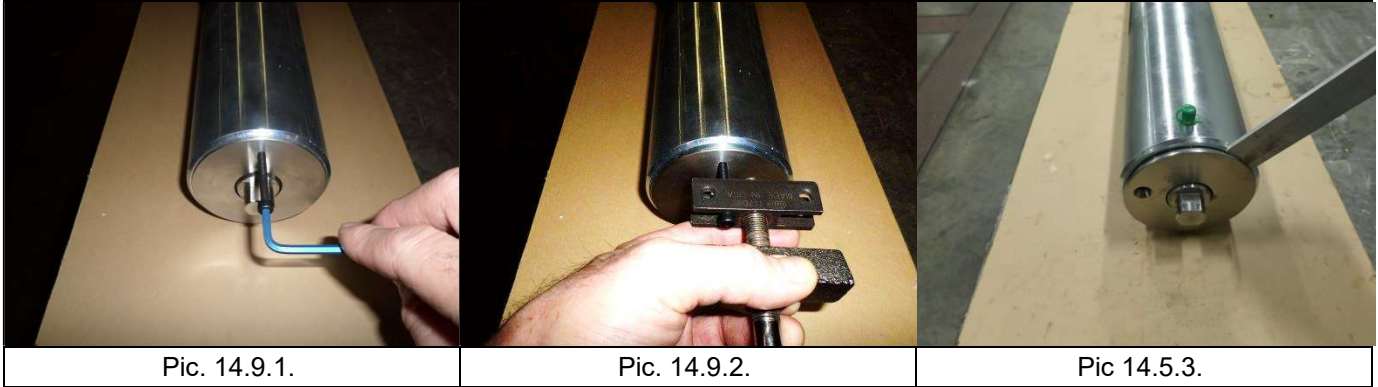
- 15.8. Screw in the M5 X 50 mm Allen bolt with M5 fender washer into the M5 'fill-hole' hole Pic. 14.9.1. Align the side puller behind the head of the M5 fender washer and gently pull the the end cover just enough of a gap to allow you to use the 2" aluminum pry tool or a 2" brass scraper to get in behind the end cover Pic. 14.9.2. Using the 2" Aluminum pry tool or the 2' brass scraper carefully pry around the end cover to loosen it for removal Pic. 14.9.3. Repeat the same for the other end cover.

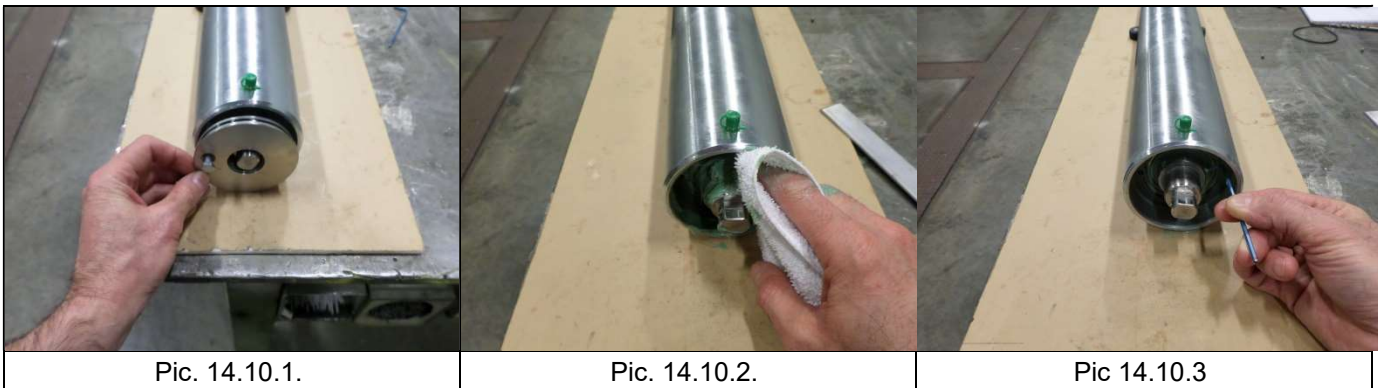
15.9. Remove the end covers Pic. 14.10.1. Using the cotton rags clean out all grease from the void area between the end cover and bearing Pic. 14.10.2. Using the 3 mm Allen wrench loosen the two bearing shaft locking set screws Pic. 14.10.3. Repeat the same for the other end of the roller.

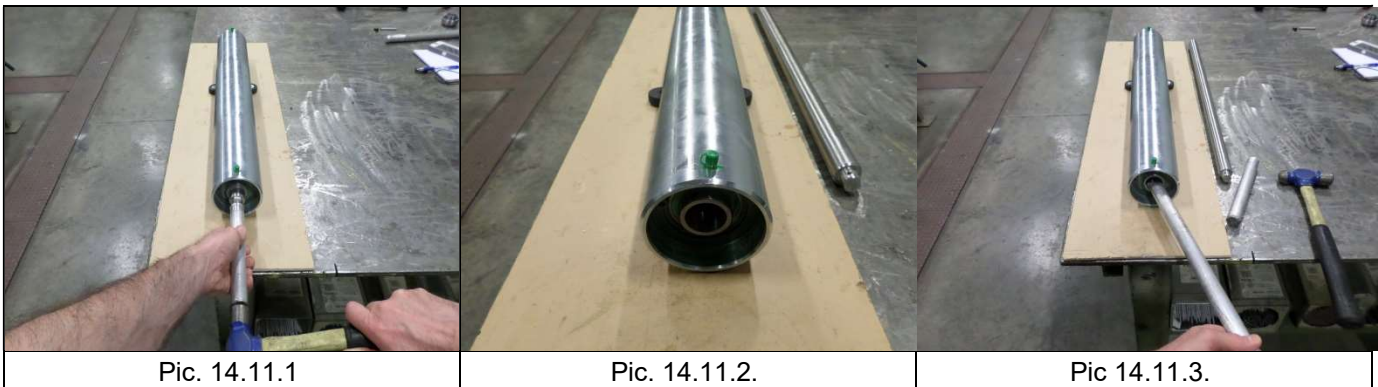
15.10. Using the 1, 1" Ø X 10-12" long aluminum drift or punch or round stock align the tool with the end of the shaft and using the 1 lb. ball peen hammer drift out the shaft Pic. 14.11.1. Remove the shaft Pic. 14.11.2.. Using the 1" Ø X 24" long aluminum drift or punch or round stock insert it through the bearing inner race sleeve and side to down the hollow part of the roller until it butts up against the bearing housing of the other side of the roller Pic. 14.11.3.

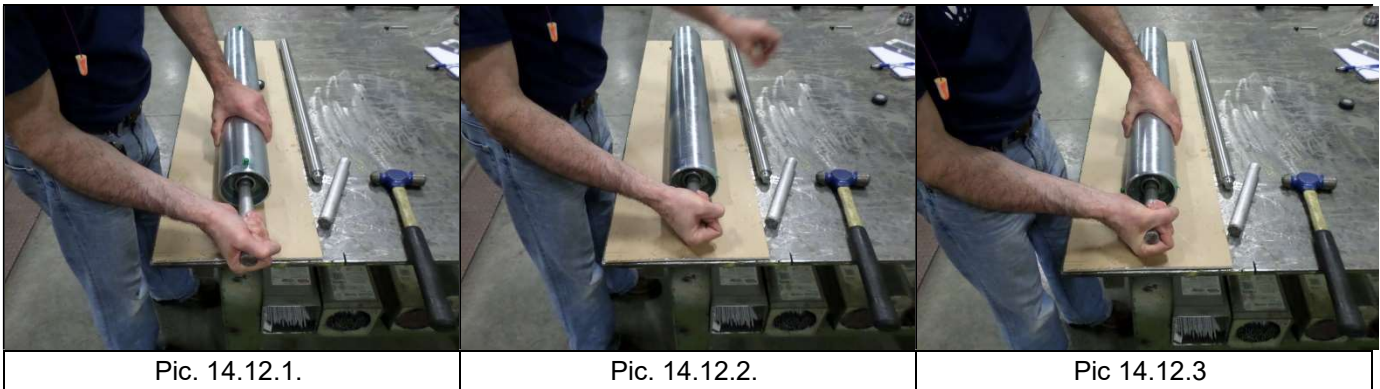
15.11. Proceed to slide the tool backwards and forwards against the bearing housing to drift the bearing housing out rotating the roller as you do so to make equal the force against the bearing housing Pics.14.12.1, 2 & 3.

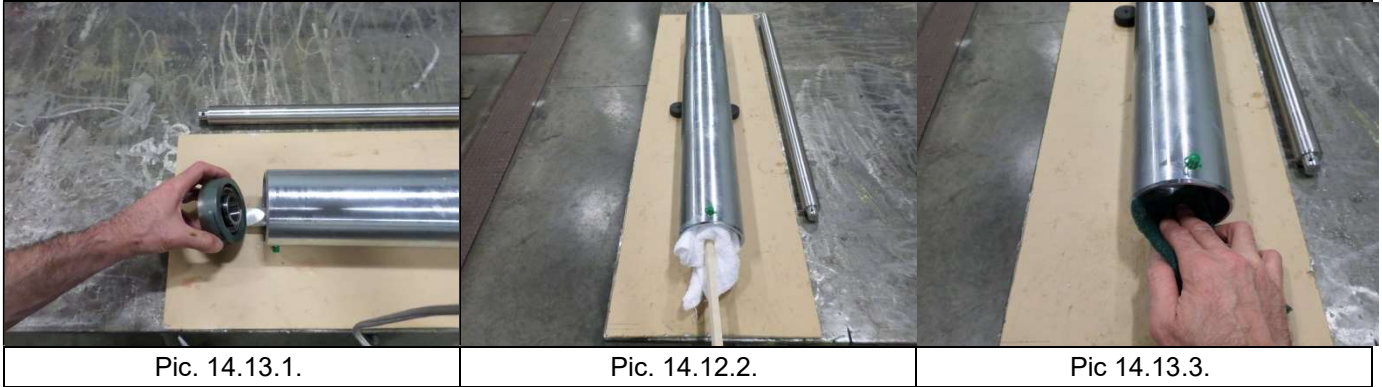
15.12. Remove the bearing housing complete Pic. 14.13.1. Repeat the same for the other end of the roller. Using rags and the piece of ½" X ½" wood push any accumulated old grease in the hollow space between each end of the roller Pic. 14.13.2. Thoroughly clean the inside of the roller of grease and ends of the inside of the roller removing any residual retaining compound from the recesses of where the bearings were removed from their internal seats using the Scotchbrite pads if necessary Pic. 14.13.3.

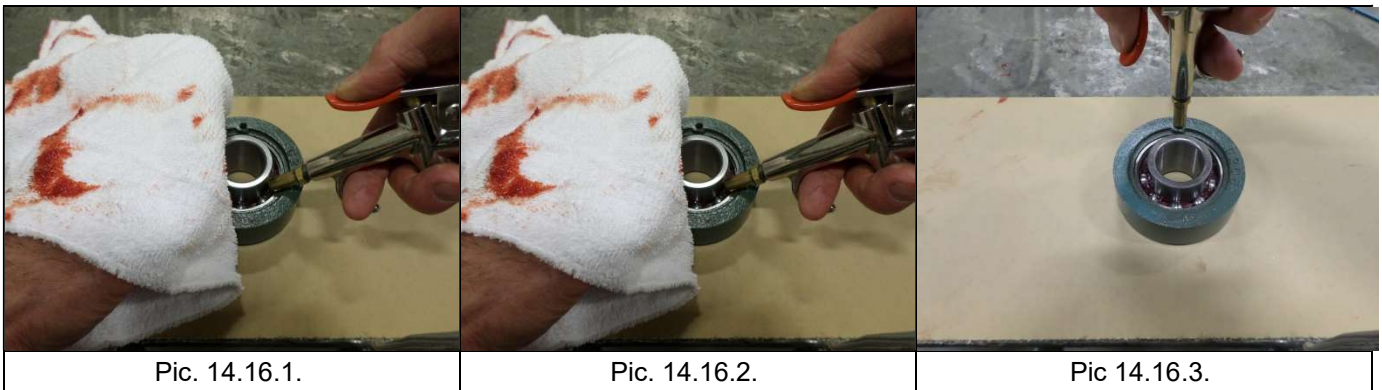
15.15. Using the air blow gun blow out all the pre-packed grease from the bearing and bearing housing grooves shielding the area around the bearing with a rag to prevent grease from being blown on your person and the work area Pic.14.16.1, 2, 3. Clean and degrease the M6 grease zerk threads with isopropyl alcohol.

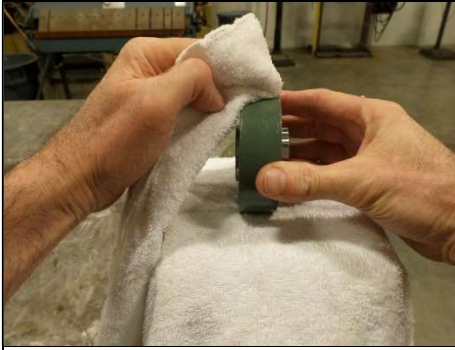
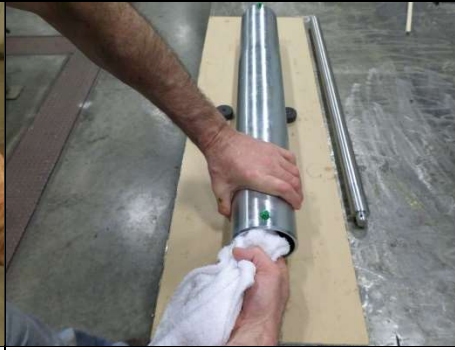
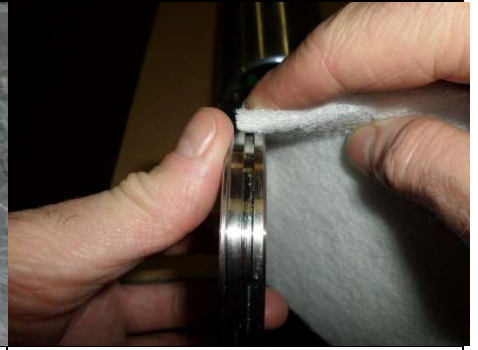
Pic. 14.18.1.

15.17. Thoroughly clean the bearing housing using a clean rag dipped isopropyl alcohol Pic. 14.18.1.. Thoroughly clean the inside ends of the roller with isopropyl alcohol and Scotchbrite pad if necessary Pic. 14.18.2. Thoroughly clean the the o-ring grooves of both end covers Pic. 14.18.3. Test to make sure the bearing fits and slides on the shaft by hand. **Note:** the bearing should fit on the shaft by hand, if it does not re-dress the shaft of burrs and the inner diameter of the bearing until the slides freely on the shaft.

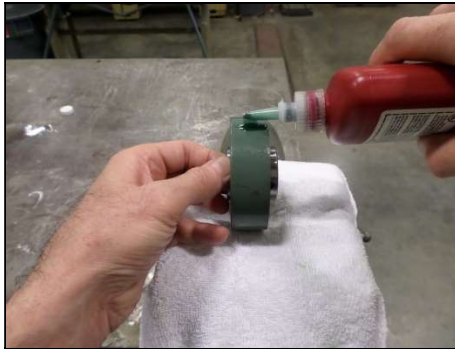
15.18. Apply a liberal amount of the Loctite 620 retaining compound to the peripheral surface the bearing housing Pic. 14.18.1.

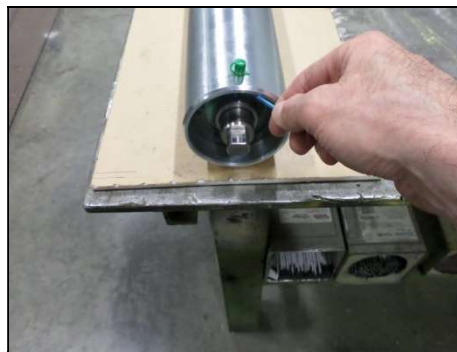
15.24. Once the correct dimension is achieved at both ends of the shaft tighten down the shaft locking set screws Pic. 15.25.1.

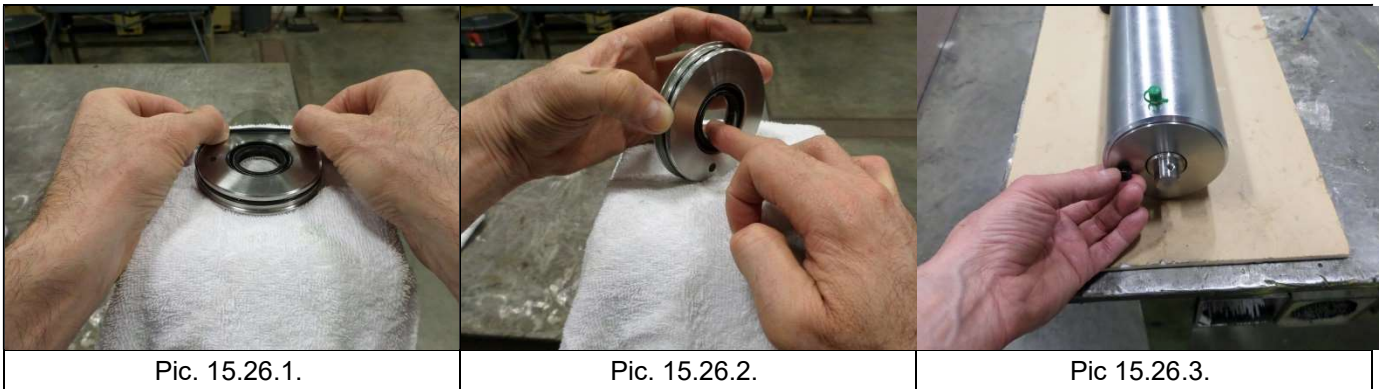
15.25. Install the o-rings back into the groove of the end covers Pic. 15.26.1. Apply a liberal amount of retaining compound around the o-ring and o-ring groove. Apply a small amount of Green Grease No 2 to the inner lips of the shaft seal Pic. 15.26.1. Align the M6 end cover screw hole with the M6 threaded part of the bearing housing and push the

end cover into the end of the roller Pic. 15.26.3. Apply Loctite 243 thread locker to the threads of the M6 X 30 mm Allen flat head screw install and tighten – **DO NOT OVERTIGHTEN**. Repeat the same on the other side of roller.

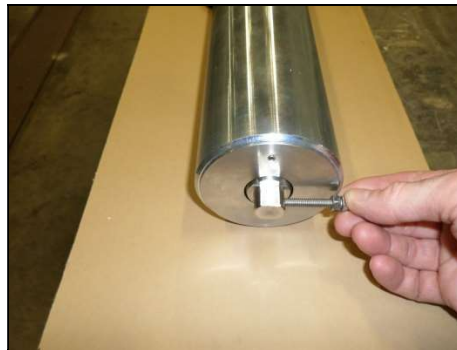
15.27. Re-install the M6 shaft jack screws Pic. 15.28.1. **Note:** Screw in the shaft jack screws so that 10 mm of thread protrudes out from the other end of the shaft. Lock the M6 shaft jack screw in place with the M6 jamb nut.

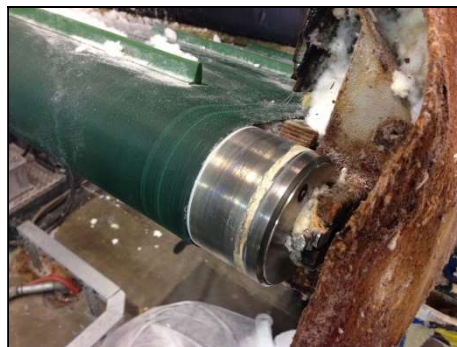
15.30. Pull the roller forward and up over to the end of the conveyor to align the shaft end with the location cleats. Rotate the shaft of the roller until the flat of the shaft is aligned with location cleats and fit in place. **Note:** Make sure the hex head of the M6 shaft jack screw is facing outwards and the ends of both jack screws are nested in the location cleats Pic. 15.30.1.
