Document Title: MAINTENANCE BULLETIN – S-MN-MB-001v0

Simpsonville, South Carolina	
Erema Melt Temperature Probe Bushing Modification				
Document Number: S-MN-CRD-XXX	Rev No: 01	Date: 05/05/14	Document Owner: Reliability & CI Manager	Approver(s): Maintenance Manager

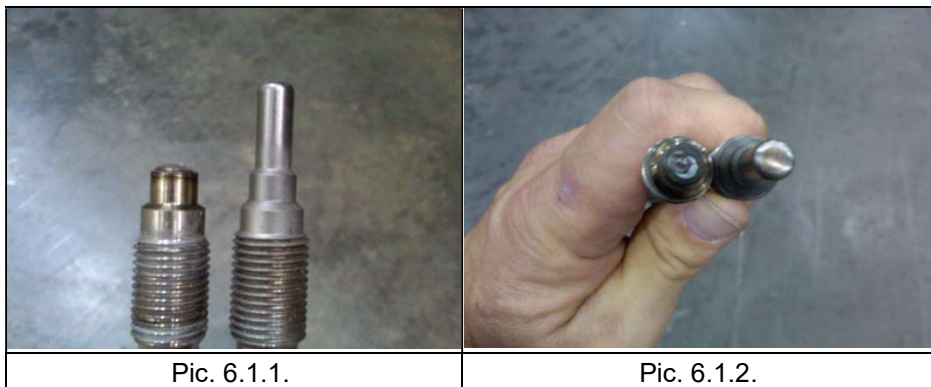
- 6.1. The Erema melt temperature probe has had a history of the tip of the probe breaking off from the body of the probe rendering the unit inoperative. The main reason is that the extruder is started from a cold or warm start up without ensuring that the plastic resin in the extruder barrel is fully plasticized (Pics. 6.1.1. and 6.1.2).

- 7.1. Following a physical analysis it was determined that there was insufficient lateral support of the tip of the probe and that longitudinal forces of the plastic melt flow was greater than the ability of the base of the probe tip to withstand being 'bent' to the point of the metal sleeve and mica fill of the probe would result in breaking down the molecular physical bonds and separate – failed state.

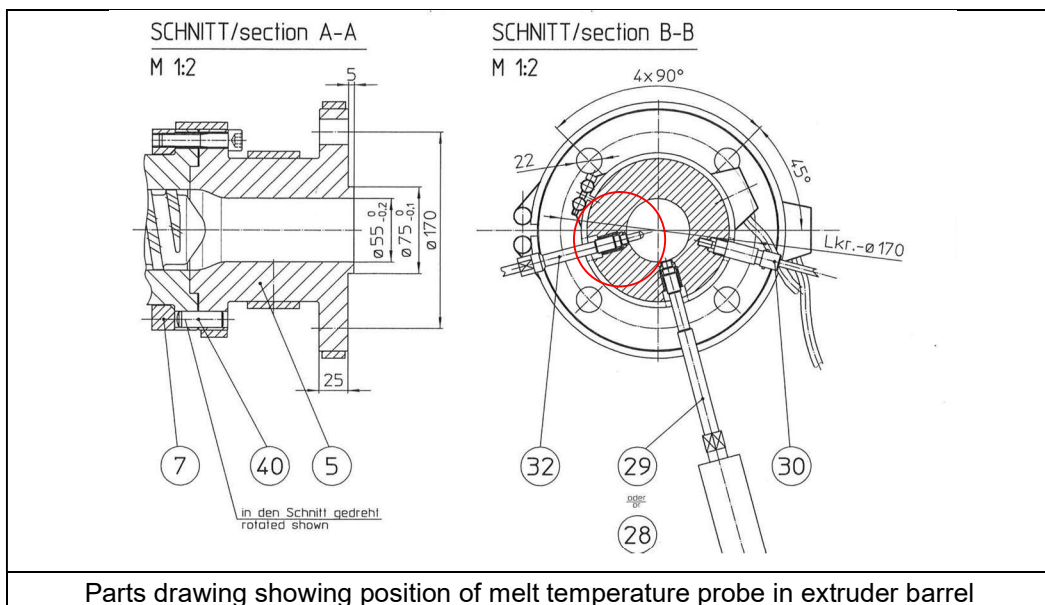
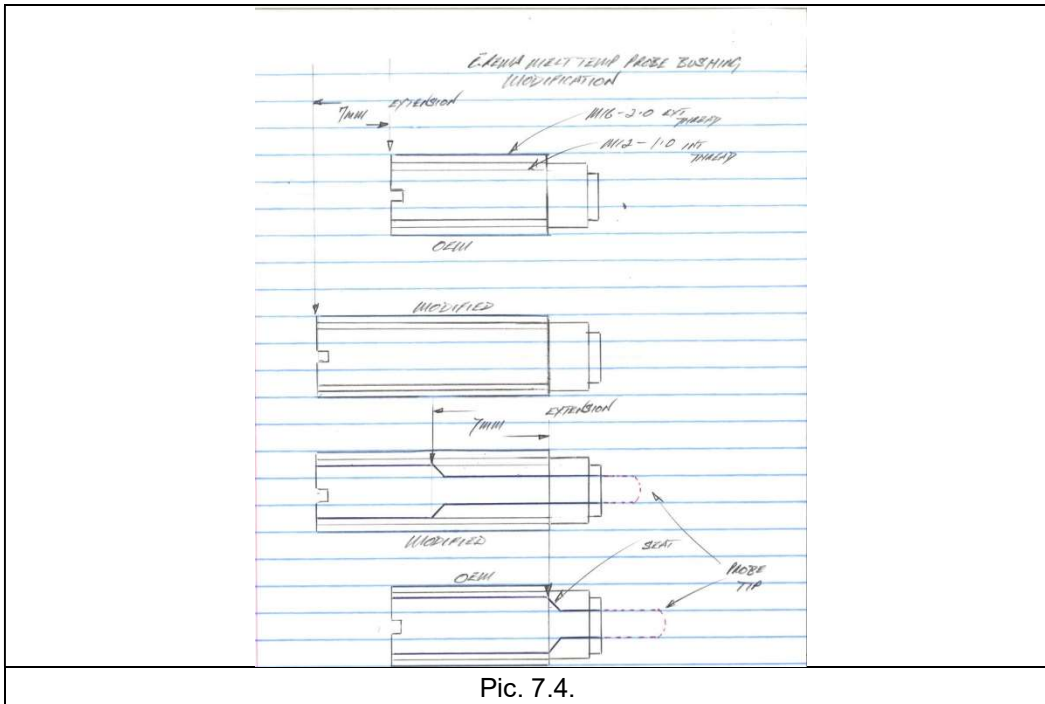
Pic. 7.4.

7.4. Modified part drawing

- 7.3. The probe has two parts; the probe itself and the bushing that it inserted to and then inserted into the extruder barrel directly into the plastic melt flow. The bushing has been modified to reduce the distance the probe extends into the plastic melt flow by 50%. Currently the probe extends 14 mm into the extruder barrel. This has now been reduced to 7 mm. This is not expected to affect the ability of the probe to accurately measure the plastic melt temperature. To achieve this modification of the bushing was necessary. The external and internal threaded body of the bushing has been increased by 7 mm. The internal seat of the bushing where the probe seal against the bushing has been moved 7 mm backwards thus is reducing the extension of the probe tip into the barrel by 7 mm. See pic 7.4

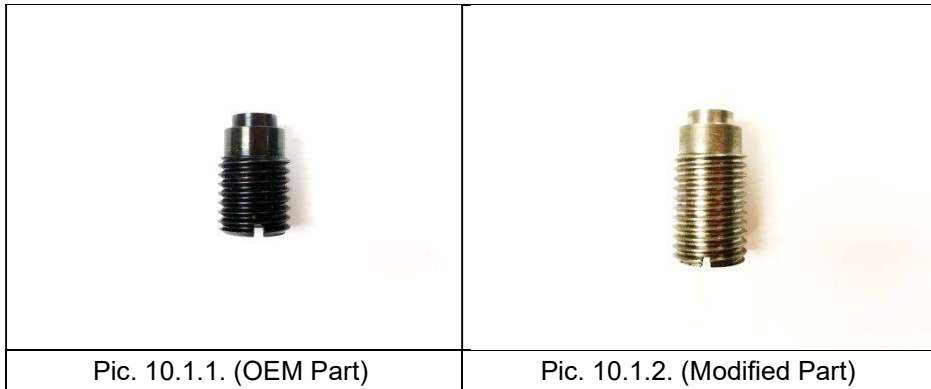
7.5. Pics 7.5.1. The original equipment manufacturer bushing and pic 7.5.2. is the modified bushing.

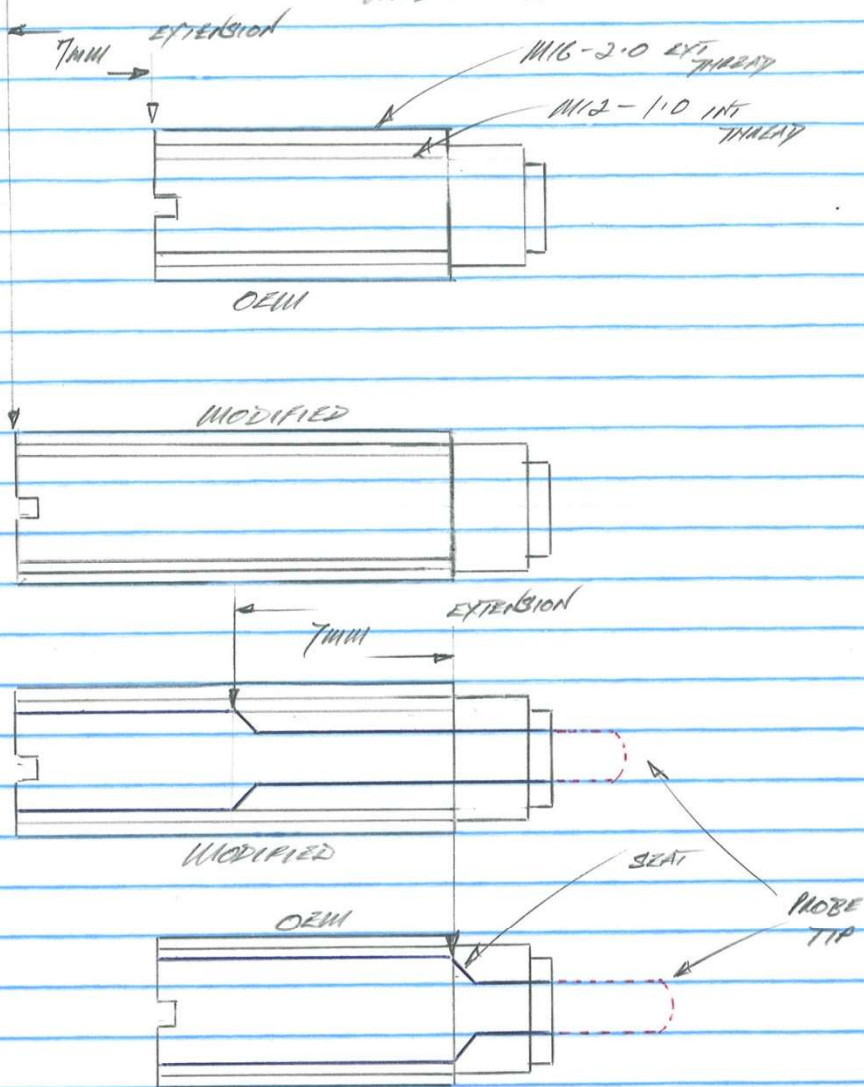
13. ATTACHMENT 1: Modified bushing drawing.

C-AREA MELT TEMP PROBE BUSHING MODIFICATION
