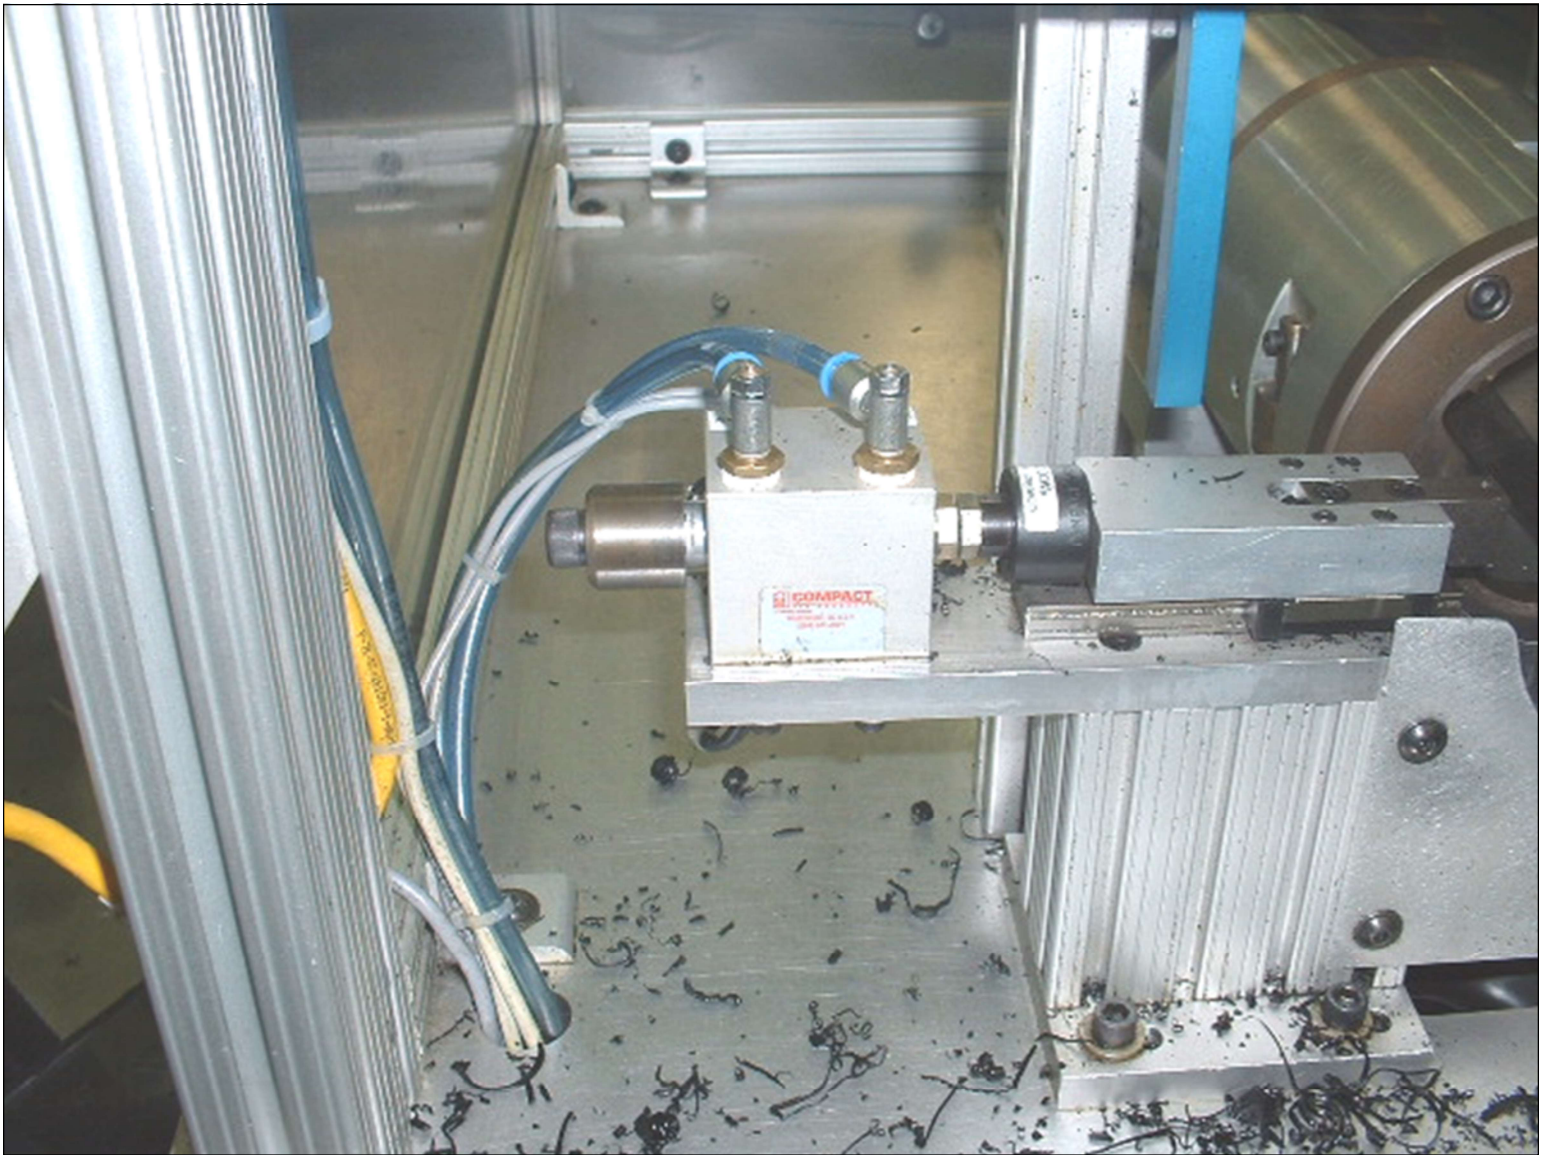
Problem here was a machine that was used to trim excess plastic from a flange of a gas filler nozzle neck for a well known luxury car manufacturer after a vulcanizing process.

The trim tool feed rate was very difficult to control the air cylinder extension speed resulting in jams and tool and product damage. I solved this problem by adopting an air-over-oil configuration using an another identical air cylinder mounted and connected to the through piston rod of the air feed cylinder.

The additional cylinder I filled with hydraulic oil and looped the extension and retraction ports with air hose using compression fittings to prevent leaks. I had to make a new longer mounting bracket too.

This modification allowed the speed of the extending tool to cut and trim into the product surface with a much improved uniform feed rate and far greater rigidity, no 'bouncing' of the cutting tool.

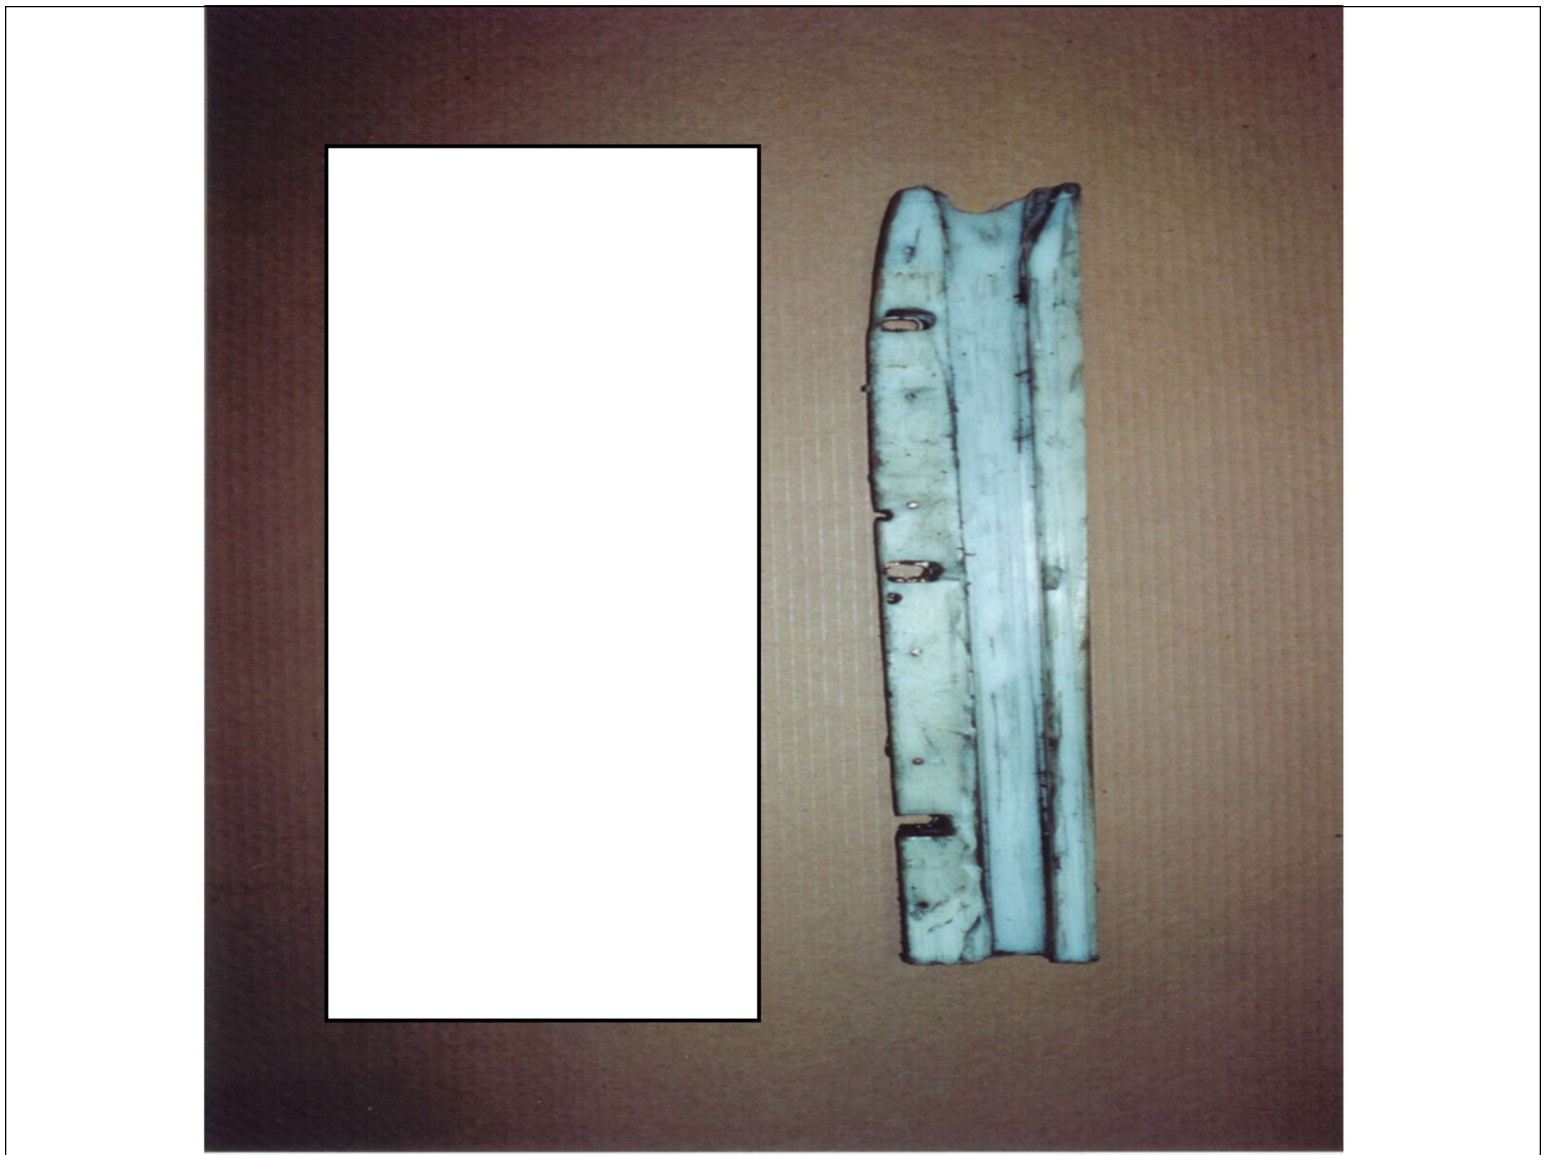
This is a vertical guide rail for a product conveyor tray. The guide would wear out quickly, so much so that the product tray would have enough lateral play on the right hand side and left hand side that jamming of the product conveyor tray happened often.

To rectify this weakness in design I redesigned the guide rail with a mounting metal plate to attach the guide rail to and changed the material that it was made from nylon to UHMW.

This significantly increased the service life of guide rail and replacement was made simpler.
