Pamphlet highlighting a full day 8 hours workshop that I conducted on TPM and 5S at the AME show at the palmetto expo center in Greenville, SC, 2005.

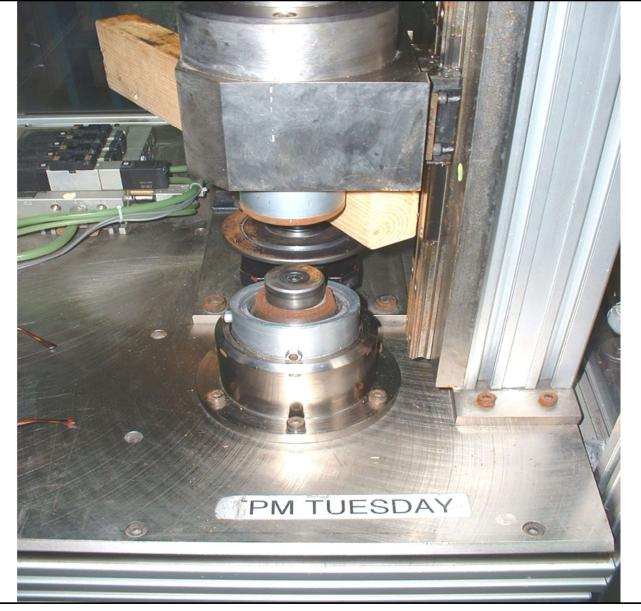
Before - a simple improvement in machine reliability with a weakness in its design where I rectified a repeated failures of thrust bearings by installation of a grease insert nipple and then setting the task of greasing to a TPM lubrication schedule.

Problem solved - never broke down again...

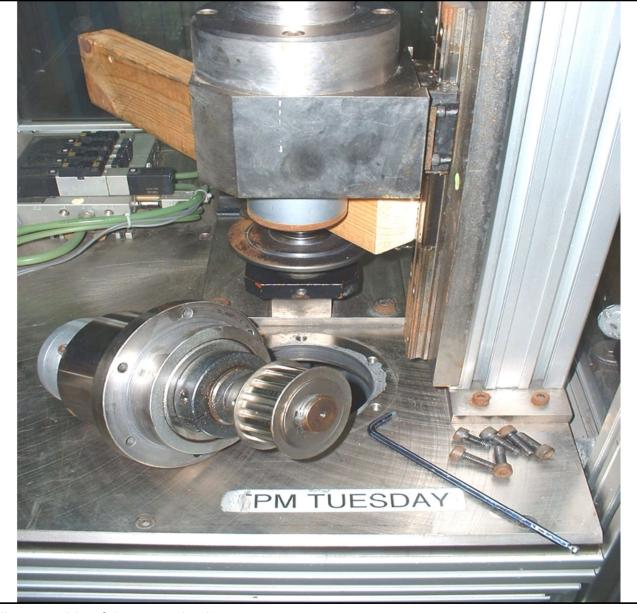
During - disassembly of the turret body...

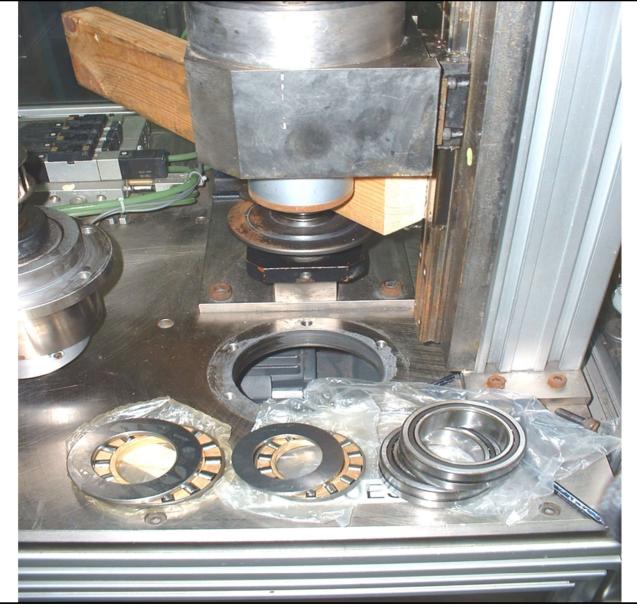
During - getting ready install new thrust bearings...

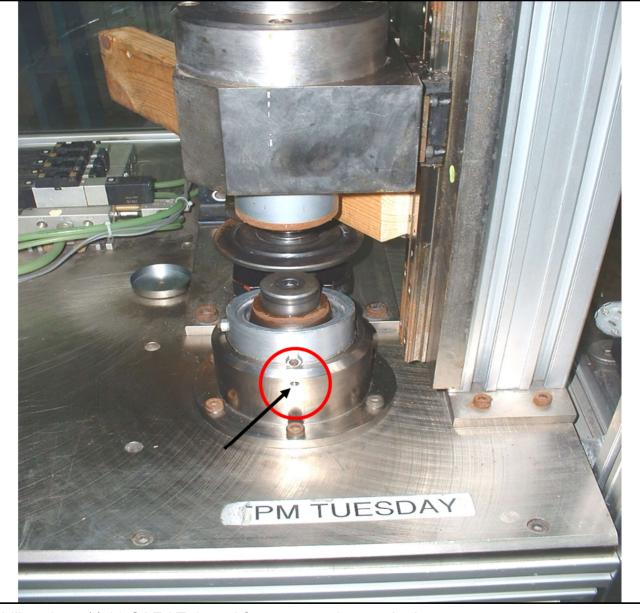
During - drill and tap  $\frac{1}{4}$ -20 SAF-LT thread for a grease insert nipple...

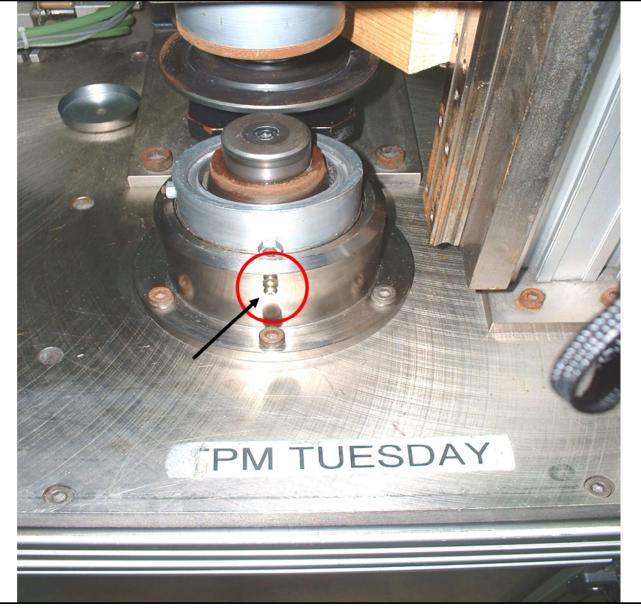
After - installed grease insert nipple and then I established a TPM routine lubrication standard and trained the machine operators to that standard...

As I said before problem solved, a simple reliability improvement, never broke down again...

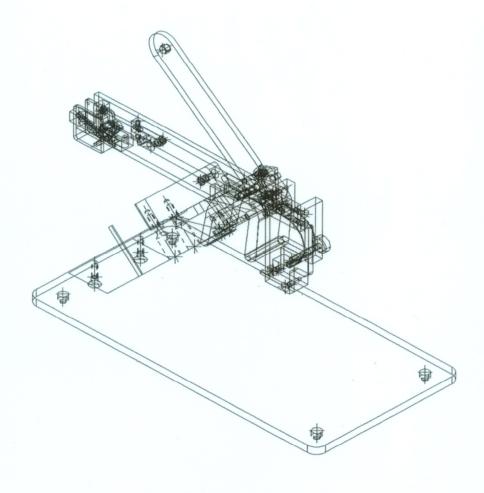
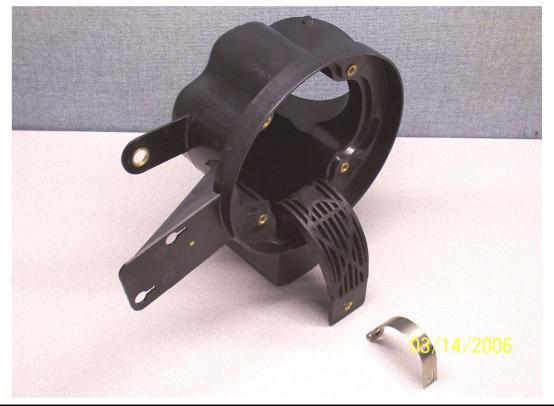
## SPRING INSERTER

Repeat failure in disassemble of a simple machine used to install a leaf spring to a car gas filler neck recess cover flap - see inset picture.

Using the methods of P-M Analysis I determined that the machine was of good design mechanically but simply was made of the wrong choice in grade of material - metal fatigue.

I had all the parts made from D-2 grade steel and hardened to Rockwell C70. I re-assembled it and as part of the TPM Autonomous Maintenance for Operators, I developed a TPM Lubrication and Bolting standard checklist - see inset. This completely eliminated the problem from mean time between failure of 5 days to infinity - to the day we stopped making the product.
