Repeat failure in disassemble of a simple machine used to install a leaf spring to a car gas filler neck recess cover flap - see inset picture.

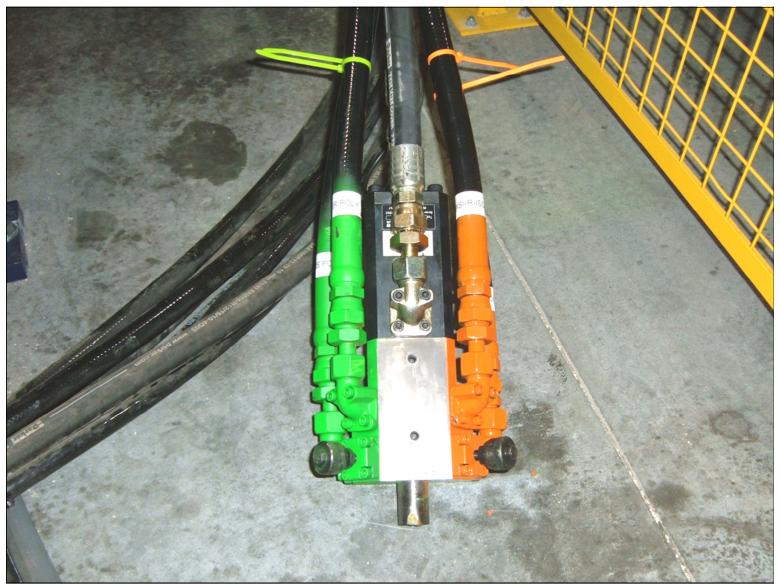
This pictures shows the high impingement mixing head from the previous slide. Quite possibly the one thing you did not want happen by any act of human omission, slip, lapse or violation with this process is crossing feed and return lines of the polyurethane and isocyanate with one another. The consequences of that failure mode are very, very expensive. We're talking hundred of thousands of dollars \$\$\$\$ replacing lines, hoses, pumps, storage vessels etc....

To err is human, but we need a poke-yoke or better still a baka-yoke approach to mistake proof this potential disaster. For our non-lean visitors poke-yoke and baka-yoke are Japanese methods of defect, mistake and error detection and prevention methods.

The baka-yoke approach here to make it physically impossible to make a mistake of screwing the isocyanate feed line hose onto the polyurethane line hose or any other combination you can think of except the right way was too expensive. It would have meant replacing all the lines on all the machines on all the mixing heads with left and right hand threaded hydraulic fittings.

So, the next best thing is poke-yoke, I color coded the fittings and hose lines and the isocyanate and polyurethane sides of the mixing head to serve as a warning that a mistake could be made - I did this spray painting all 25 machines mixing heads and lines. Continued on next page.

I would like to think that in 10 years time the reason why we didn't have to deal with that mistake and resulting effect and consequences was by designing it out of capability of happening...
