SIX SIGMA PROJECT CHARTER - DEFINE

PROJECT TITLE 2300C PRODUCTION LINE SCRAP REDUCTION & SECONDARY EQUIPMENT RELIABILITY IMPROVEMENT

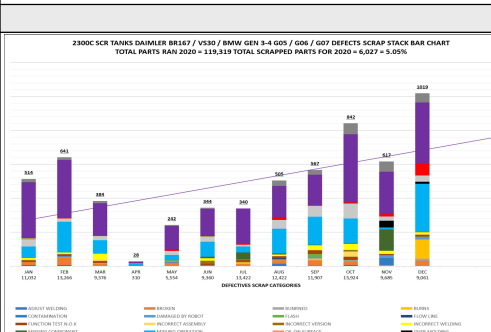
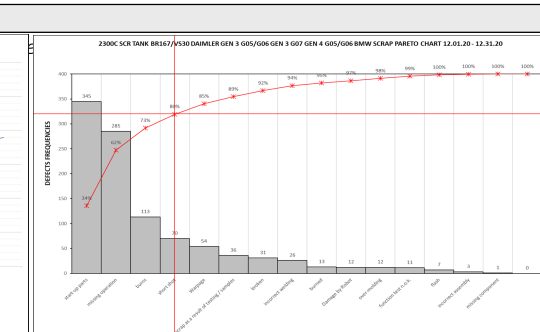
2300C BASE LINE MEASUREMENT

- 2300C Daimler BR167 SCR Tank Total parts ran in 2020-21 YTD = 63,864 - Total scrapped parts in 2020-21 = 3,275 = 5.1%
- 2300C Daimler VS30 SCR Tank Total parts ran in 2020-21 YTD = 18,727 - Total scrapped parts in 2020-21 = 1,554 = 8.2%
- 2300C BMW Gen 3 G05/G06 SCR Tank Total parts ran in 2020-YTD = 21,624 - Total scrapped parts in 2020-21 = 1,266 = 5.8%
- 2300C BMW Gen 4 G05/G06 SCR Tank Total parts ran in 2020 = 15,104 - Total scrapped parts in 2020-21 = 1,090 = 7.2%
- 2300C Roll Throughput Yield 2021 to date as of 10.08.21 is 84.23% as a measure of long term performance.

- MTBF = 2.9 hrs - MTTR = 1.5 hrs - 41.5 hrs downtime - 42 breakdowns average between survey period of 06.14.21 to 07.26.21
- Conducted a measurement of historical data taken from the data aquisition registry detailing measured failure for both 0040-3017193 Shell to Shell Welder and the 0080-3017195 End Of Line Tester which yielded invaluable information for in process failures which can be view in the EVIDENCE tab of this charter by clicking on the hyperlink 0040-3017193 Production Data. Also the same information for the 0080-3017195 End Of Line Tester click on the hyperlink 0080-3017195 Production Data.

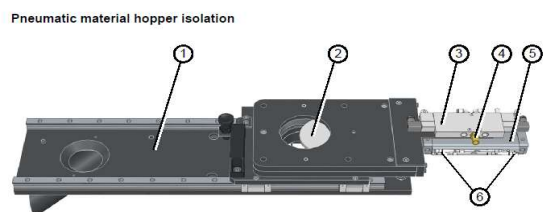
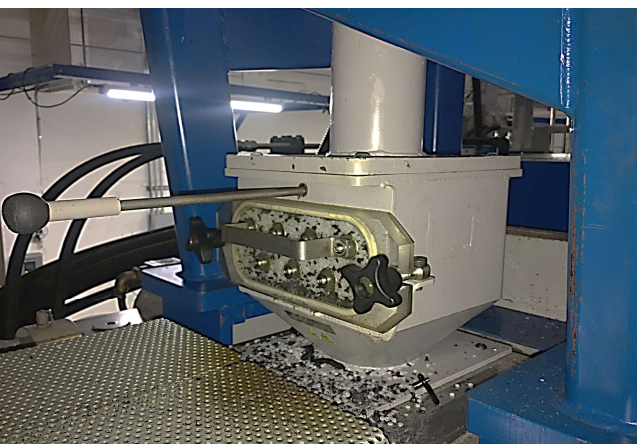
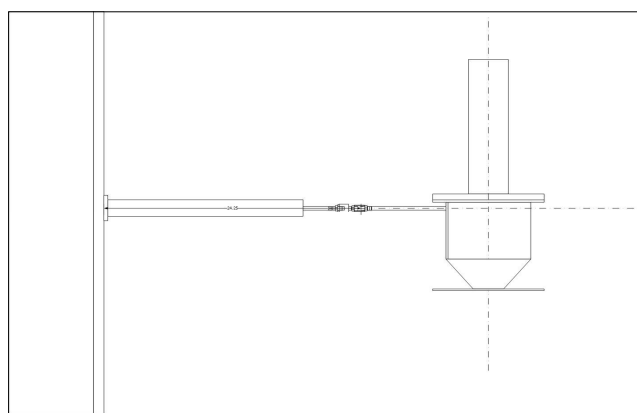
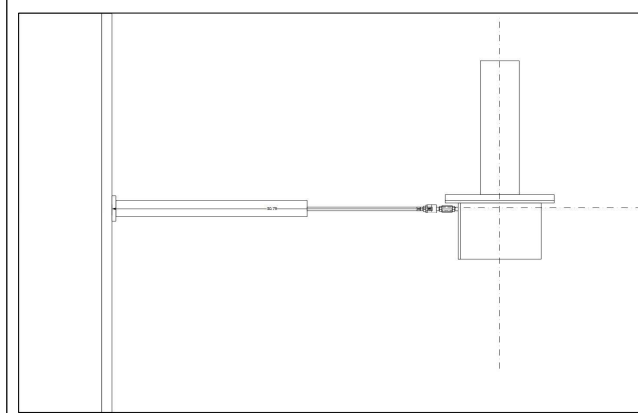
4.00 INSTALL A MANUALLY CONTROLLED PNEUMATICALLY OPERATED THROAT SLIDE VALVE ON - This is to alleviate the need to manually operate the slide valve by hand

| <p>PROPOSAL FROM ENGEL FUTURE STATE AIR CONTROLLED</p> <p>Pneumatic material hopper isolation</p> <ol style="list-style-type: none"> [1] Material hopper displacement unit [2] shut-off solenoid [3] Pneumatic valve [4] Connection for air maintenance unit [5] Pneumatic cylinder [6] non-contact end position switch <p>PICTURE 4.01</p> | <p>CURRENT STATE MANUALLY OPERATED SLIDE VALVE</p> <p>PICTURE 4.02</p> | <p>MY OWN DESIGN (VALVE OPEN)</p> <p>PICTURE 4.03</p> | <p>MY OWN DESIGN (VALVE CLOSED)</p> <p>PICTURE 4.04</p> |

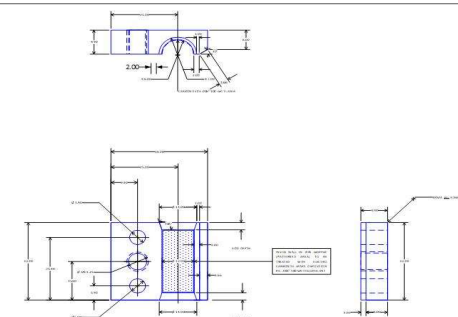
| | | | | | | | | | | | | | | | | |
|--|---|---|---|---|---|---|---|---|---|--|---|--|---|---|---|--|
| 20.00 REPLACE WORN OUT ASSEMBY 2 VENT PIPE GRIPPER TOOL - Currently we are gluing sand paper to the gripper tools because there is insufficient friction force between the inner contact surface of the vent hose gripper tools and the outside surface wall of the vent | | | | | | | | | | | | | | | | |
| DRAWING OF VENT PIPE GRIPPER TOOL

<small>ALL DIMENSIONS ARE IN MILLIMETERS MATERIAL: A2 STEEL MITRE (CASE HARDENING)</small> <small>2300C BMW G05/G06/G07 ASSEMBLY 2 VENT PIPE GRIPPER TOOL</small> <small>Notes: As mentioned on the drawing I need to have the inside wall of the gripper treated with a "sand paper" application process called Electro Spark Carbonize Deposition to the grade of #3, 00F or 300grit equivalent. Please let me know if you are able to do this.</small> <small>DRAWN BY: FRED WEBBERING ENGINEER: FRED WEBBERING AUTOMOTIVE CONTACT: 864-257-2330 fwebbering@cashtrig.com</small>

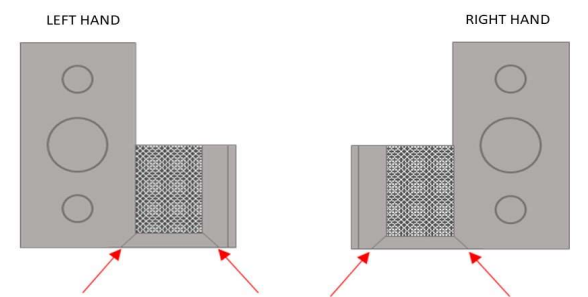
| PICTURE 20.09 | PICTURE 20.10 | PICTURE 20.11 | PICTURE 20.12 | |

| 20.00 REPLACE WORN OUT ASSEMBY 2 VENT PIPE GRIPPER TOOL - Currently we are gluing sand paper to the gripper tools because there is insufficient friction force between the inner contact surface of the vent hose gripper tools and the outside surface wall of the vent | | | | |
| ILLUSTRATION OF MODIFIED GRIPPER TOOL | TITLE OR DESCRIPTION OF PHOTOGRAPHIC EVIDENCE HERE | TITLE OR DESCRIPTION OF PHOTOGRAPHIC EVIDENCE HERE | TITLE OR DESCRIPTION OF PHOTOGRAPHIC EVIDENCE HERE | |

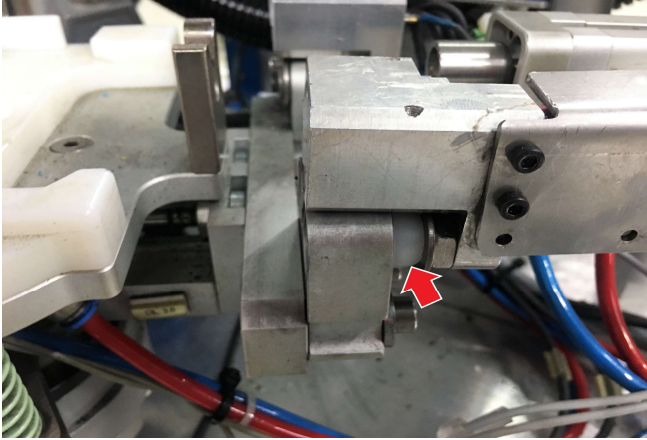
| PICTURE 22.01 | PICTURE 22.02 | PICTURE 22.03 | PICTURE 22.04 | |

| 22.00 REPLACE SILICONE RUBBER BUSHINGS ON 0080-3017195 END OF LINE TESTER FOR BR167 FIXTURE - One of the bushings was missing and three others were worn out | | | | |

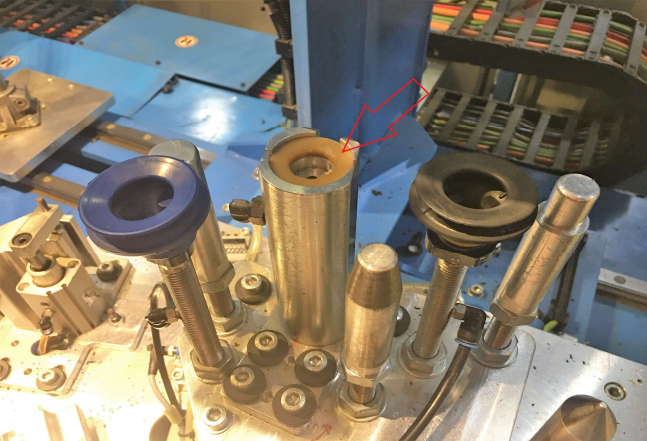
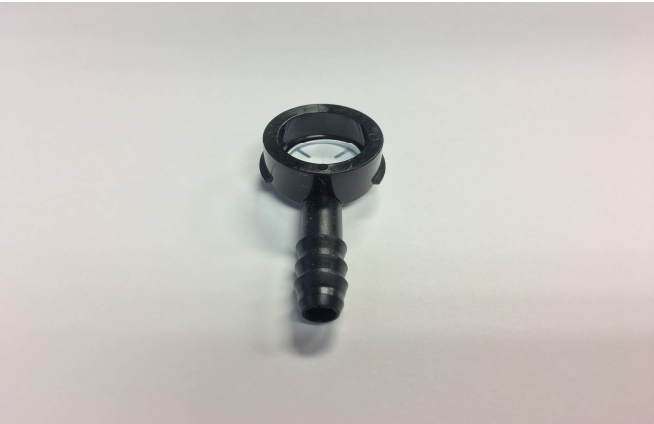
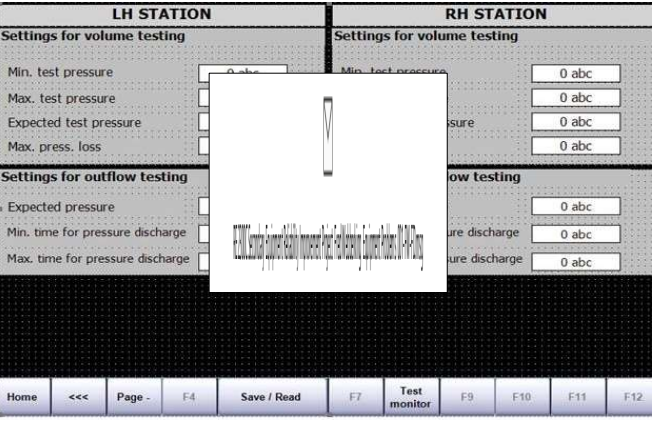
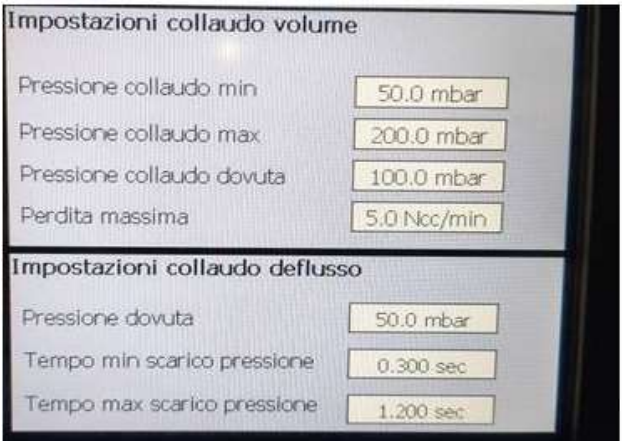
| PICTURE 24.01 | PICTURE 24.02 | PICTURE 24.03 | PICTURE 24.04 | |

| 24.00 0040-3017192 REFURBISH PUMP TO SHELL WELDER WORN TOOLING FOR VS30 - The latest equipment abnormal phenomenon is with the 0040-3017193 Shell To Shell Hot Plate Welder. Occasionally we will have a machine stoppage and error which will display on | | | | |
| VS30 MEMBRANE CHECK VALVE WELD FIXTURE | MENBRANE CHECK VALVE | SCREEN SHOT 1 | SCREEN SHOT 2 | |

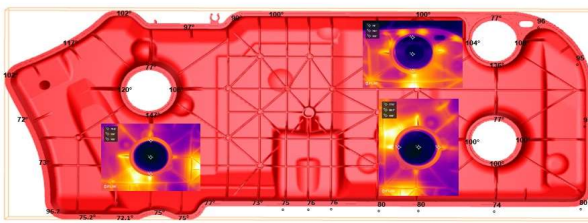
PICTURE 25.01

25.00 THERMO IMAGES - thermo images of BR167

UPPER SHELL PART TEMPERATURES AT END OF EXIT CONVEYOR

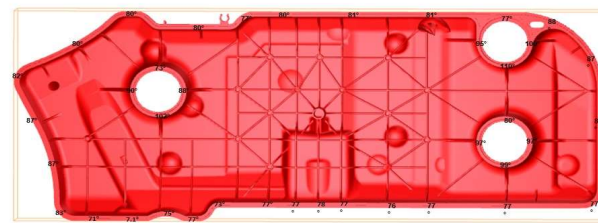
PICTURE 25.02

UPPER SHELL PART TEMPERATURES AT SHELL TO SHELL WELDER

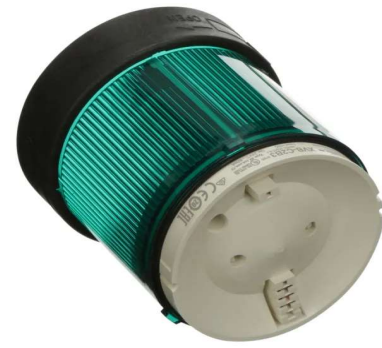
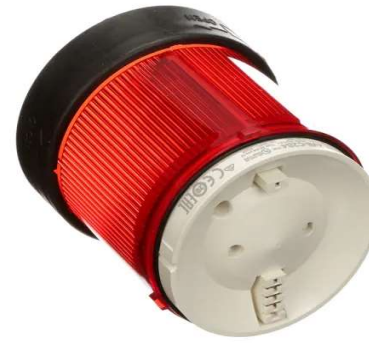
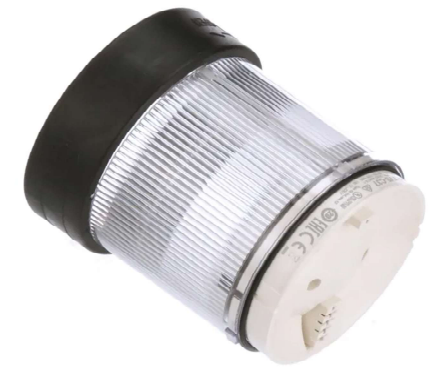
(ARROWED) 0220-1730194-2016-155 UPPER SHELL ASSEMBLY STACK LIGHT TOWER)
 REQUESTING TWO (2) REPLACEMENT STACK LIGHT TOWERS. THERE ARE TWO MOUNTED INSIDE THE MACHINE ON BOTH SIDES. BOTH ARE DAMAGED AND I WAS UNABLE TO DETERMINE THE MANUFACTURER'S NAME OR ANY DETAILS ABOUT HOW MANY LIGHTS AND COLORS WERE ON THE STACK TOWER. I HOPE MAYBE YOU HAVE A RECORD OF WHAT YOU INSTALLED ON HERE.

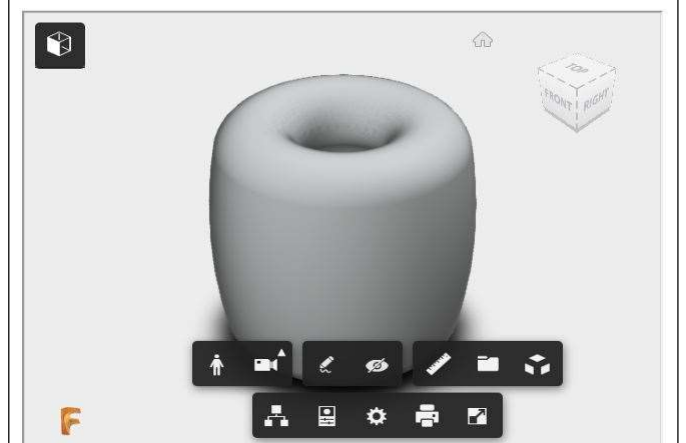
PICTURE 34.04

REPLACEMENT SILICONE BUSHING FOR TEST HEAD BR167

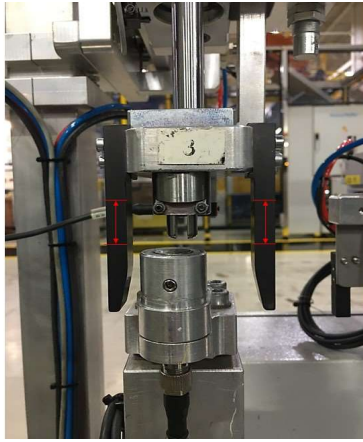
PICTURE 36.01

36.00 3017195 END OF LINE TESTER - Replacement parts and components for the end of line tester fixture and fitting and machine.

VS30 #30 BUSHING FORK ALIGNMENT REPLACEMENT UPGRADE

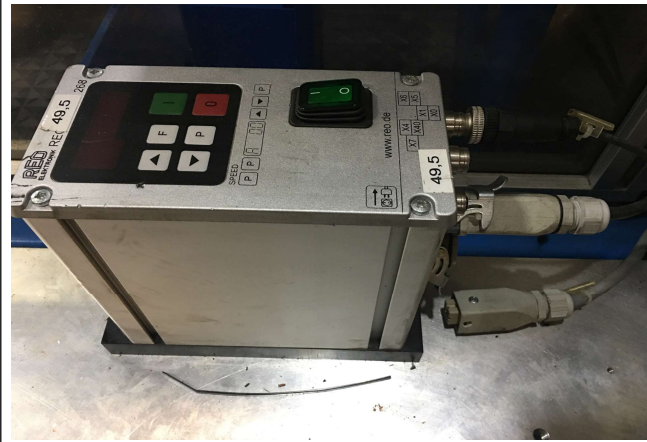
PICTURE 36.02

REPLACEMENT BUSHING CONVEYOR FEED VIBRATER MODULE

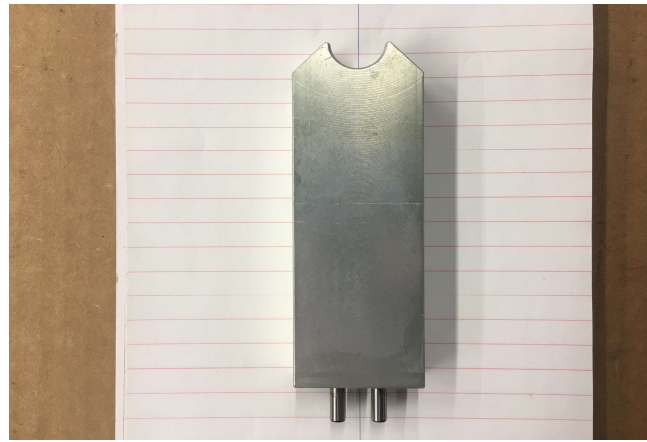
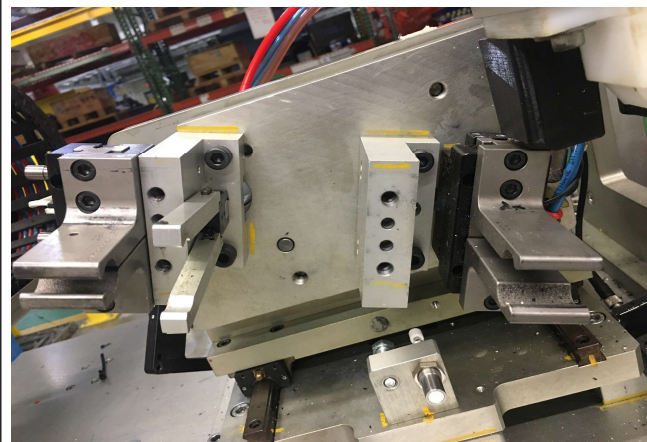
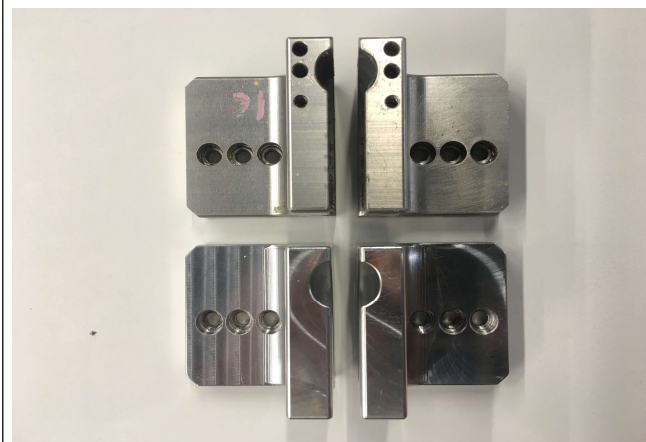
37.00 3017194 UPPER SHELL ASSEMBLY BR167 TOOLING - Additional tooling replacement because of being worn or damaged.

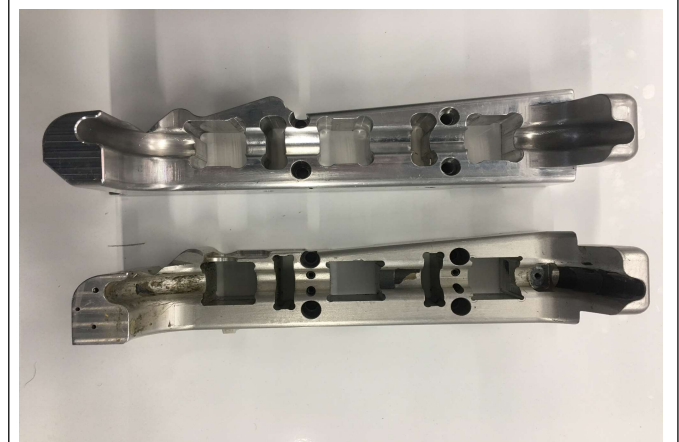
PICTURE 37.03

BR167
