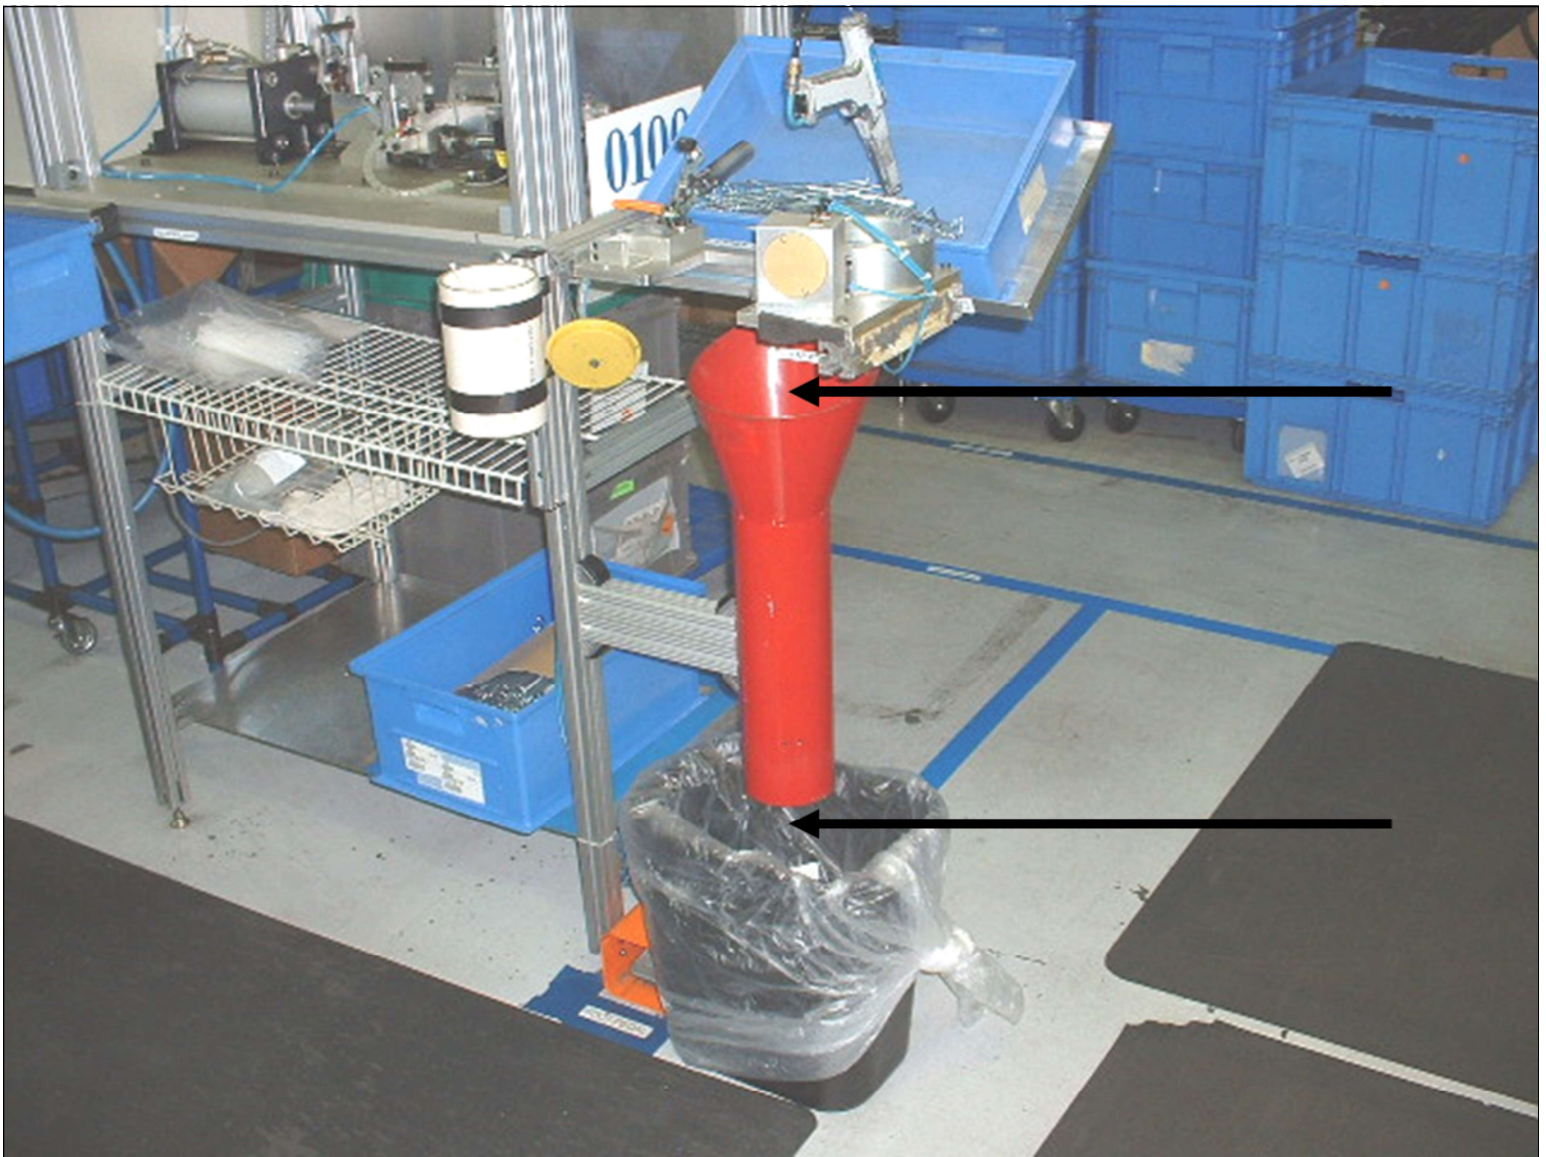
5S cleaning... finding ways to make the cleaning process easier to carry out. Inspired by toll road stations and those coin funnels I made and installed this waste chute funnel at a product detailing work station in which several small cable ties were installed and the excess length cut off.

This use of a funnel and tube capturing the waste of the cable ties cuttings made the whole cleaning a snap at the end of the shift...

No money fun - I used a disused section of an electrical conduit for the chute and an disused injection molding hopper filler for the funnel.

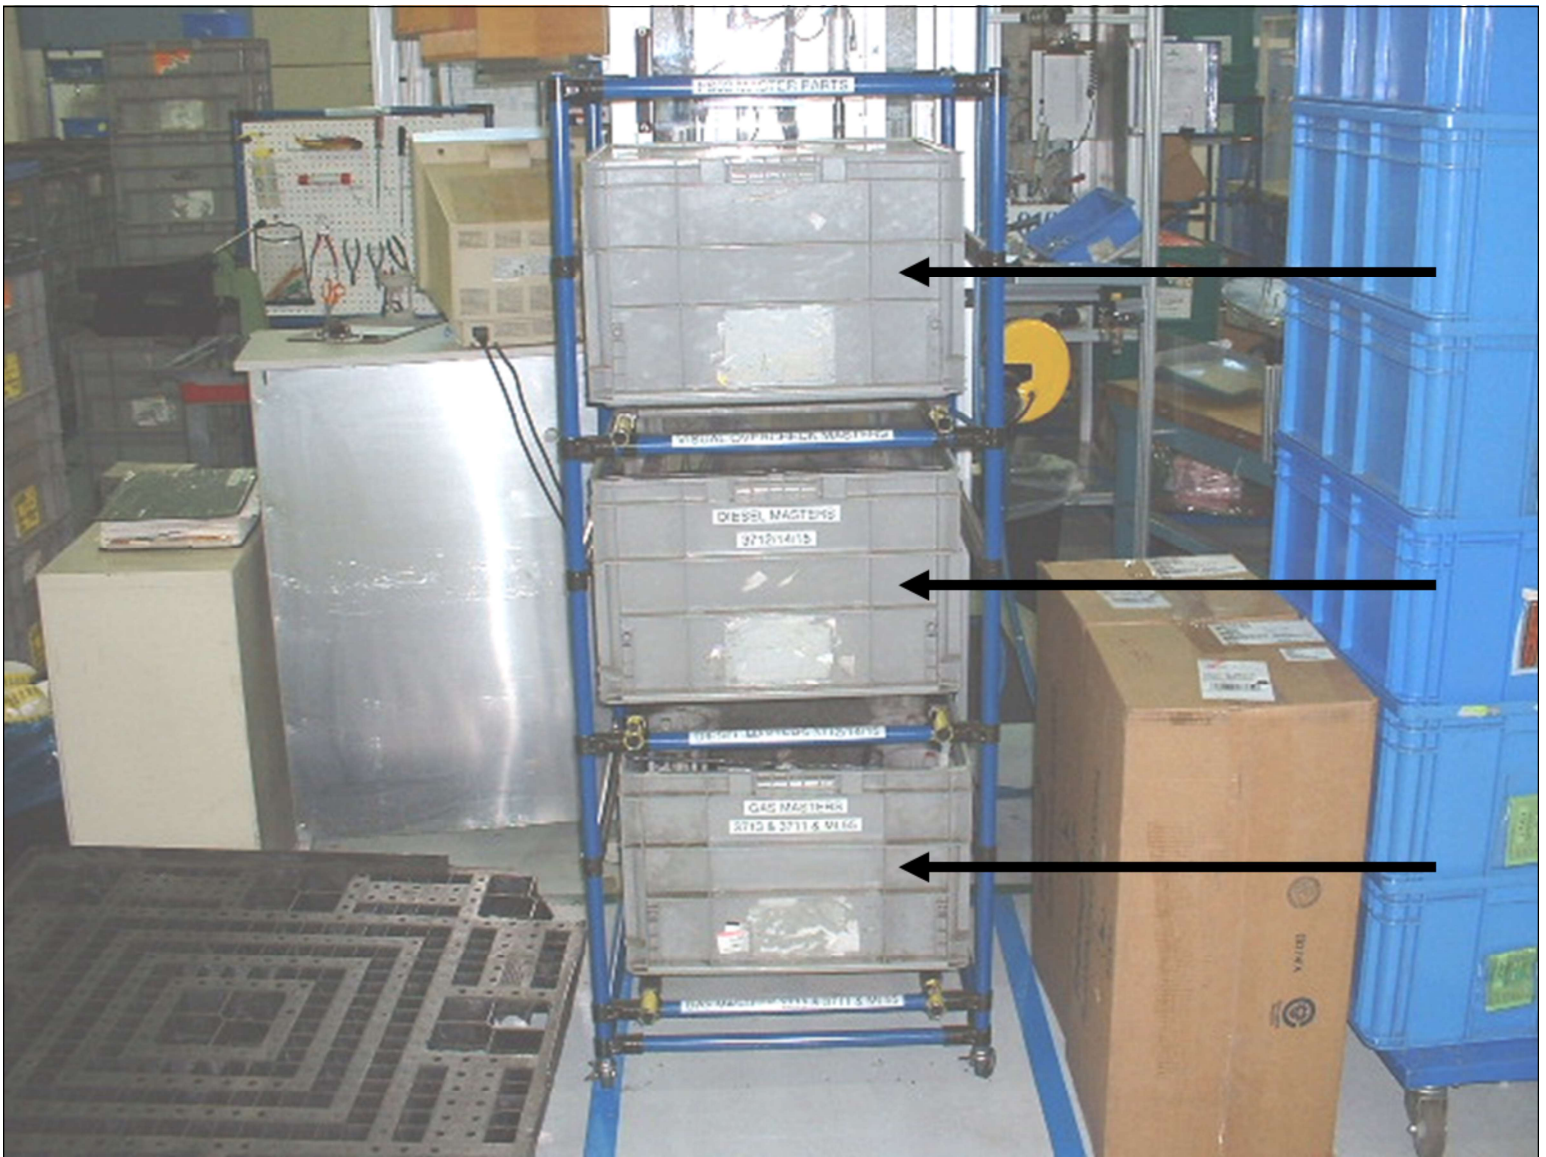
5S and organization... This picture shows a tote rack that I designed and made to store master test parts.

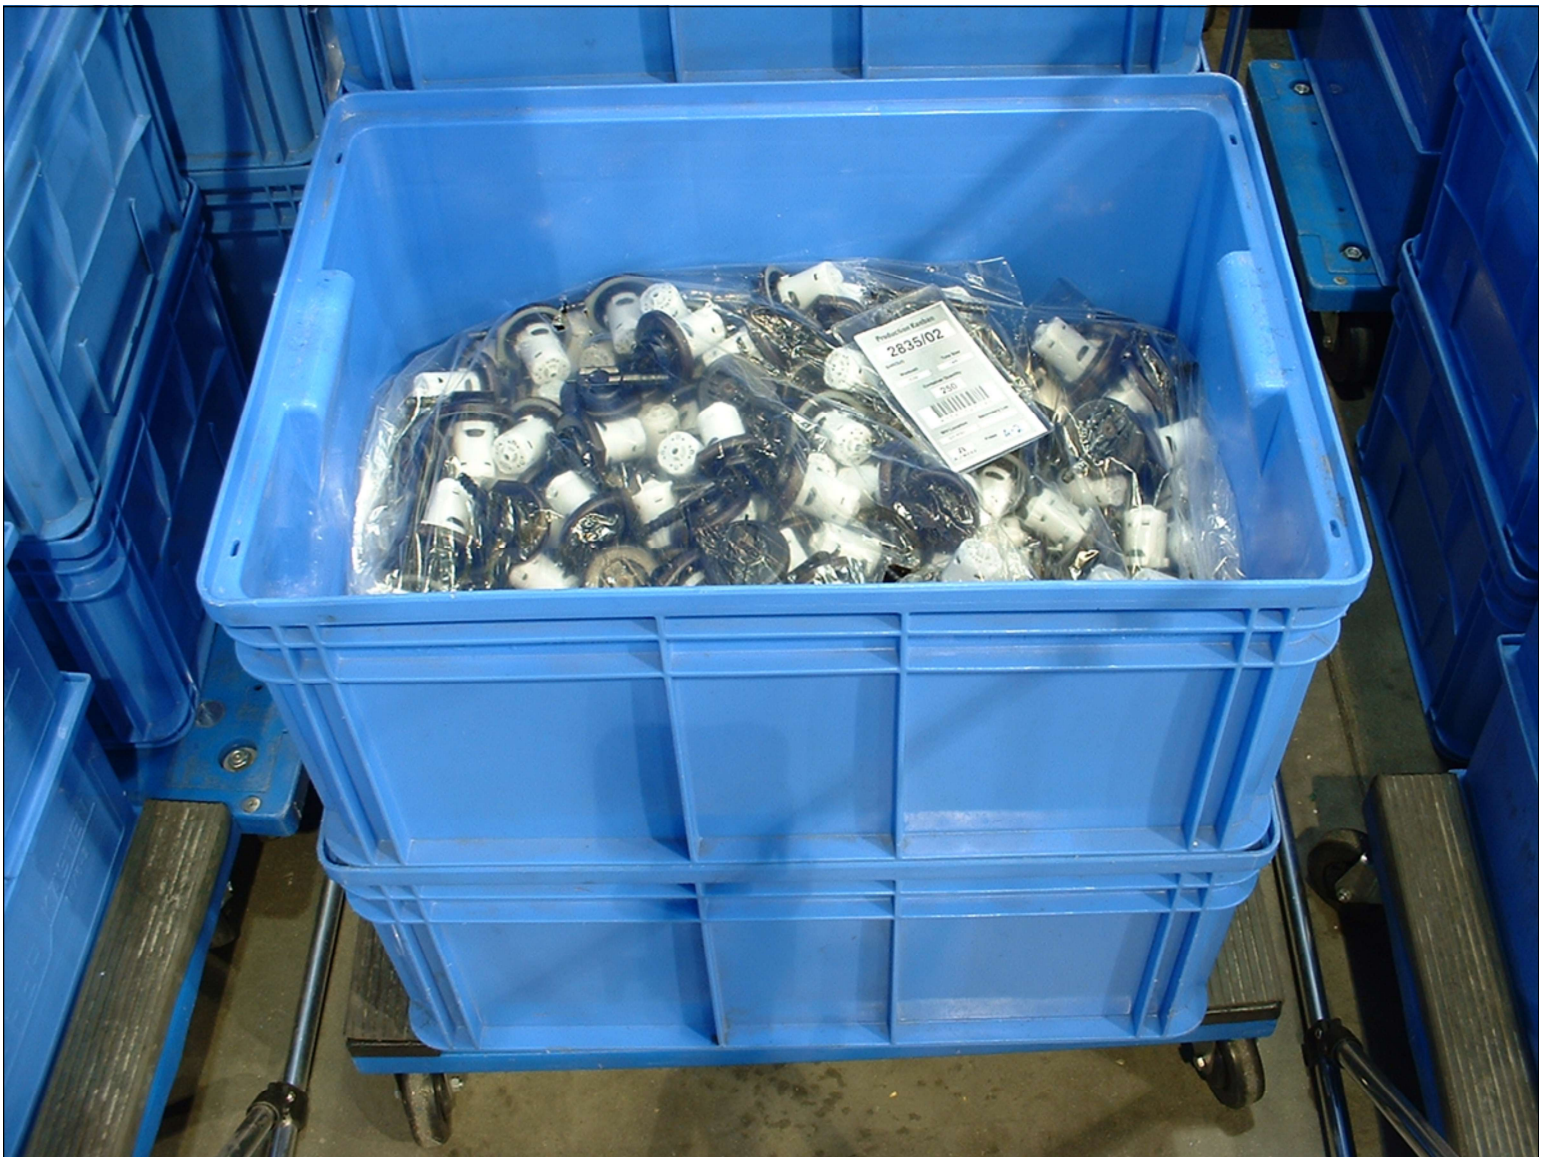
5S and organization... putting finished goods parts in totes, in plastic bags to prevent contamination, that's - good...

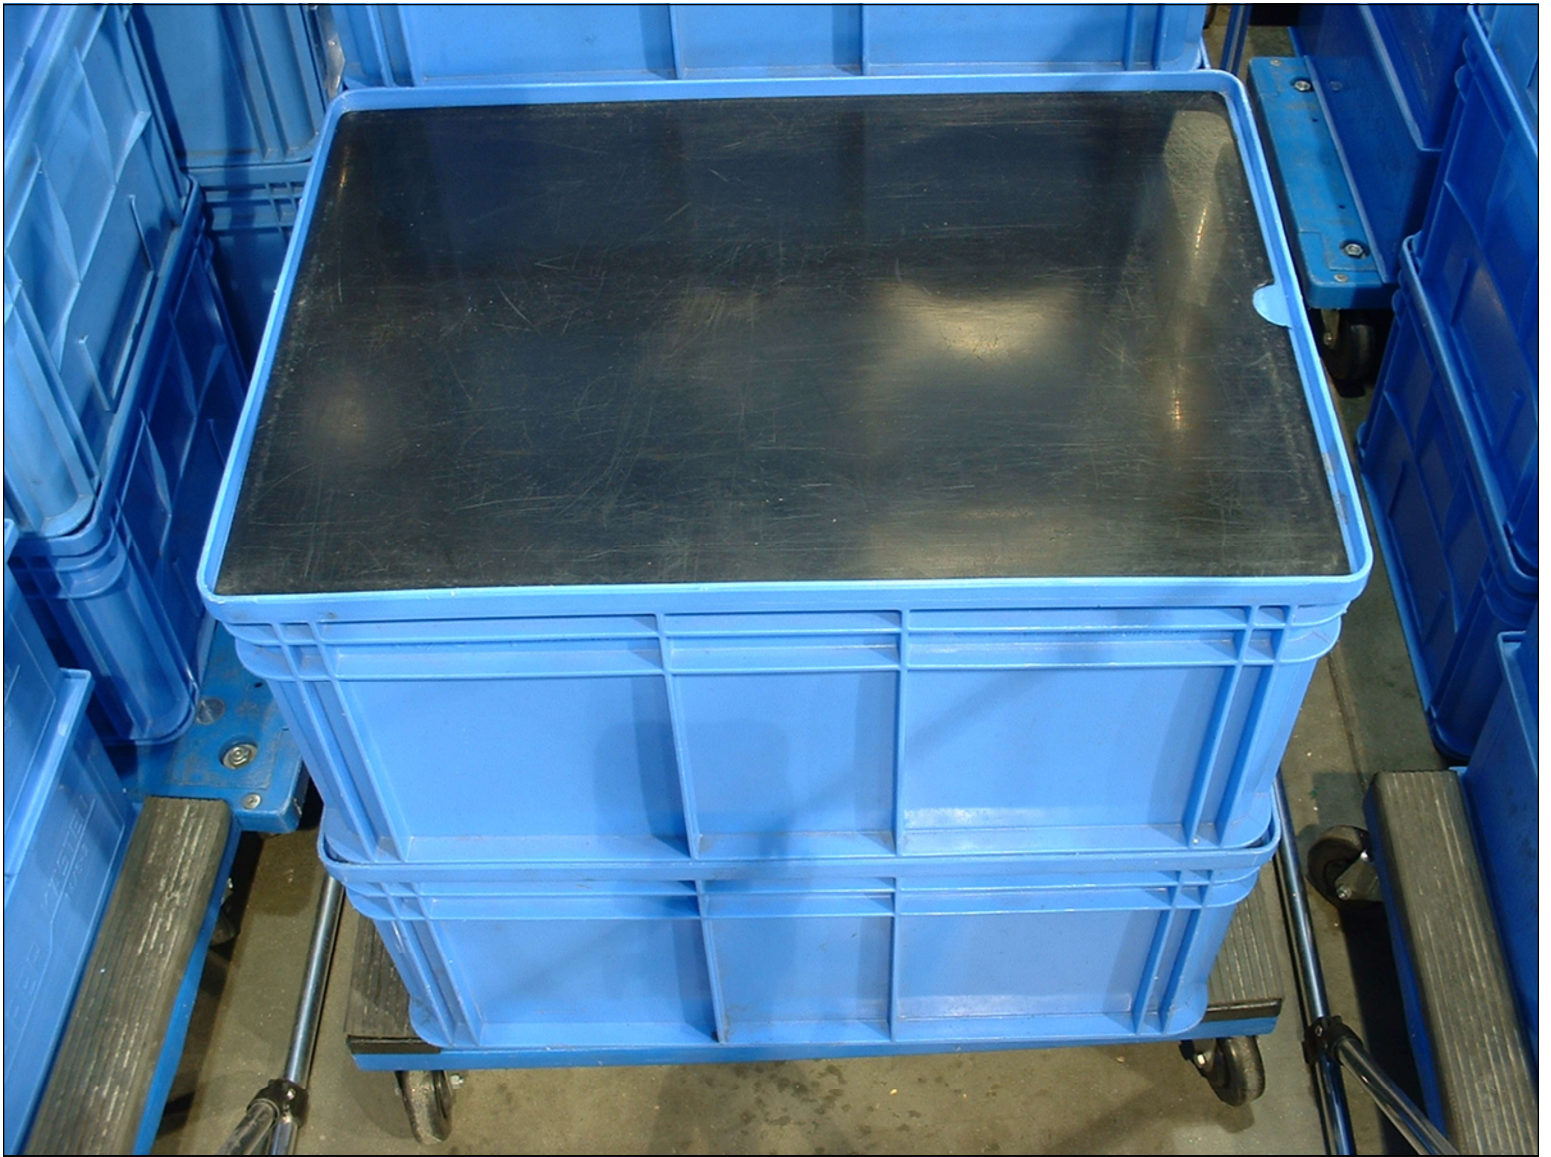
5S and organization... putting finished goods parts in totes, in plastic bags to prevent contamination with a fitted lid on the tote, that's - better...

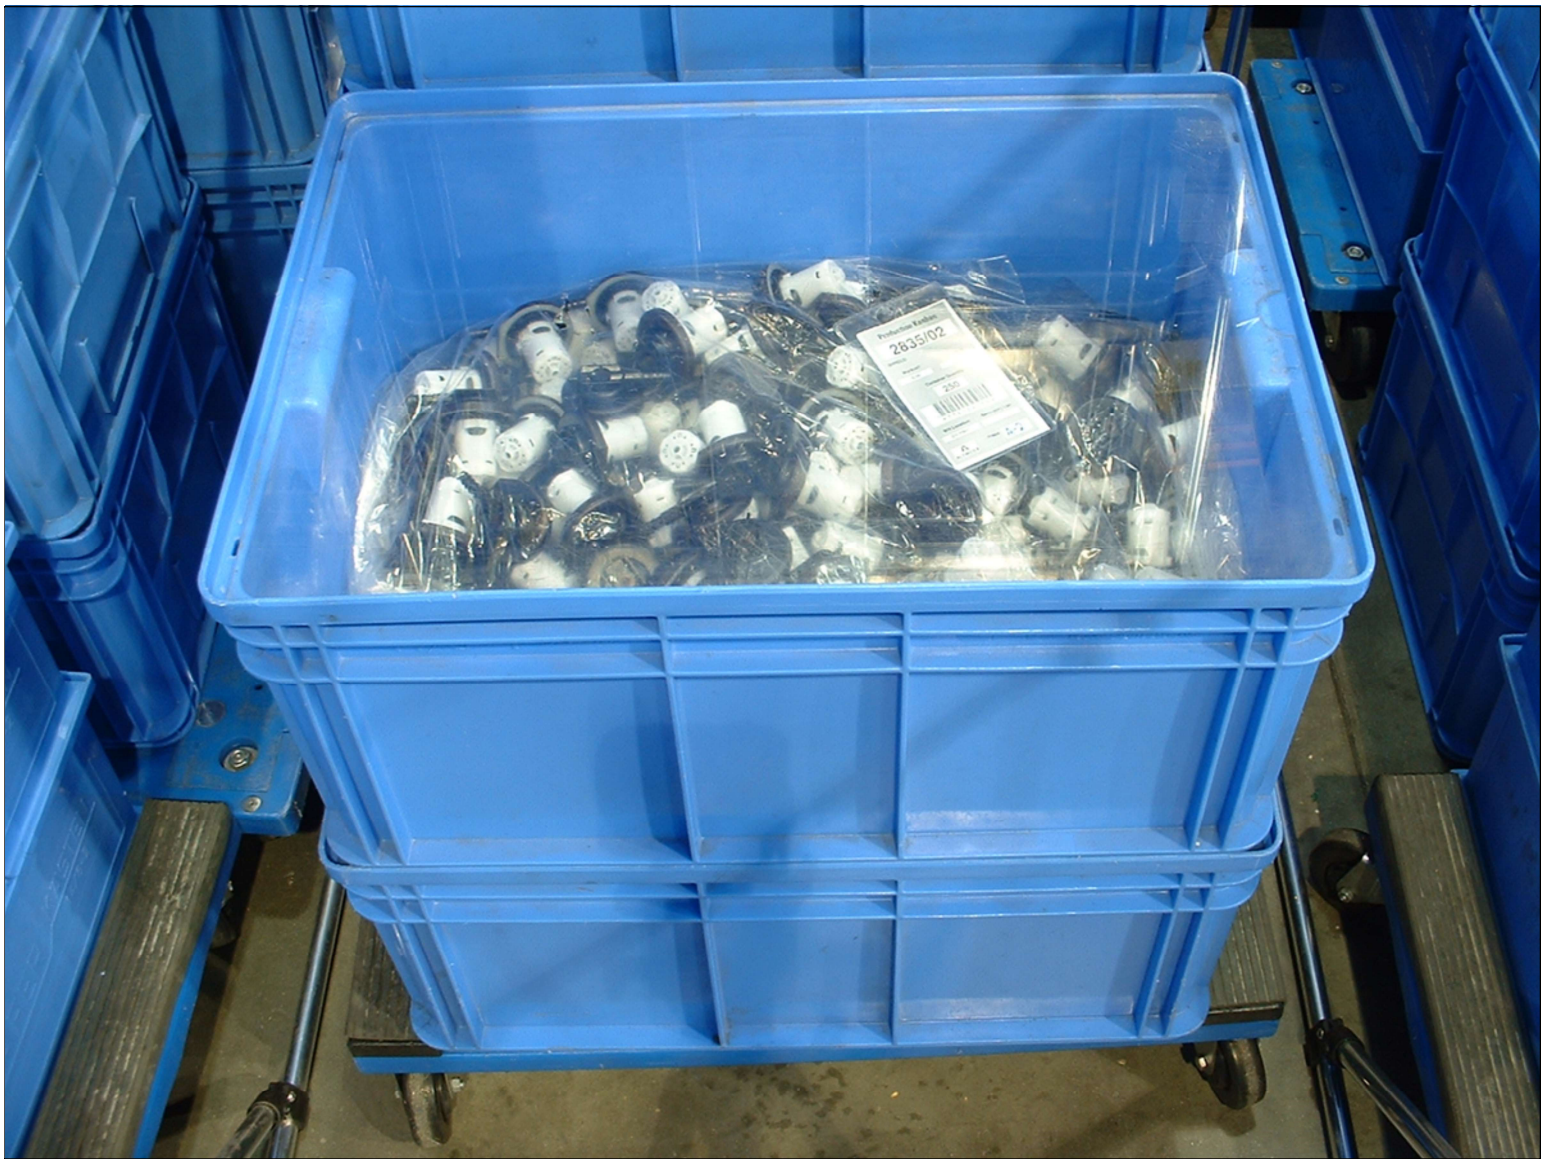
5S and organization... putting finished goods parts in totes, in plastic bags to prevent contamination with a fitted 'clear' lid on the tote for visual management, that's - best...

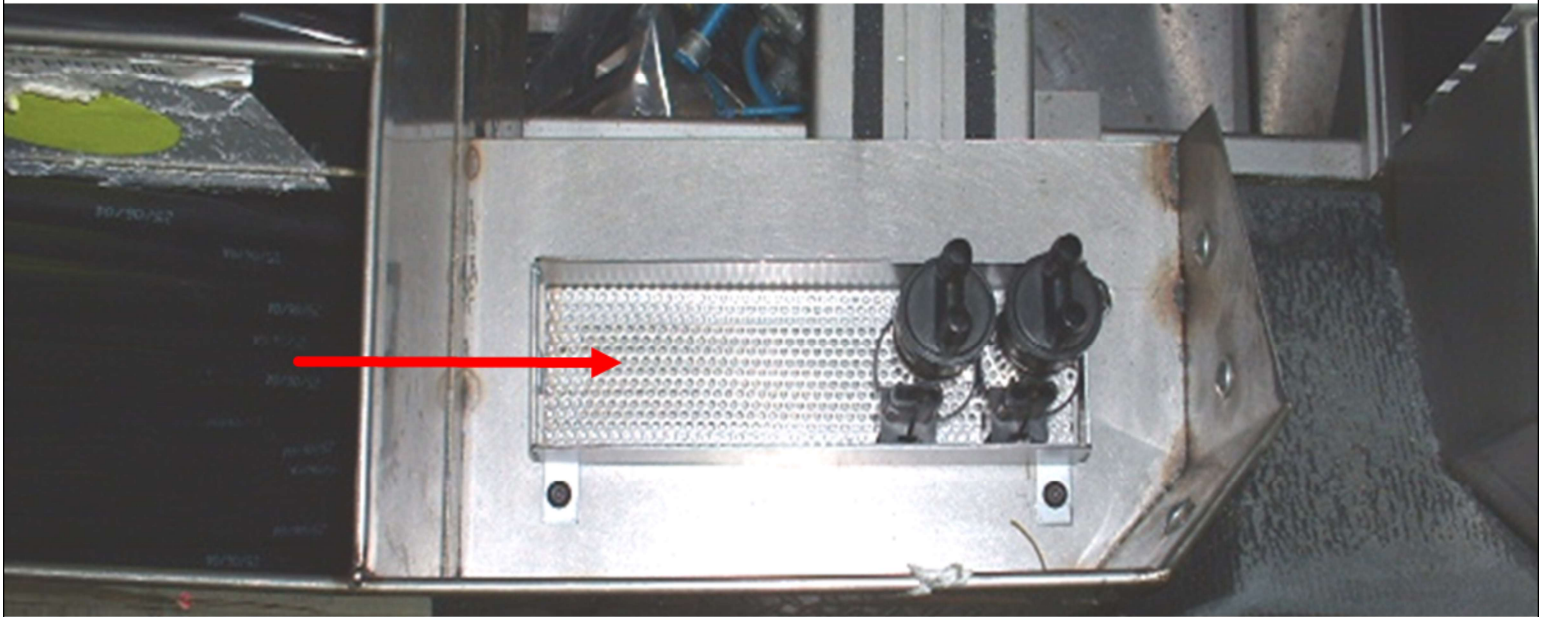
5S and contamination control using a perforated stainless steel plate in a holding container to prevent dirt, dust and debris build up.

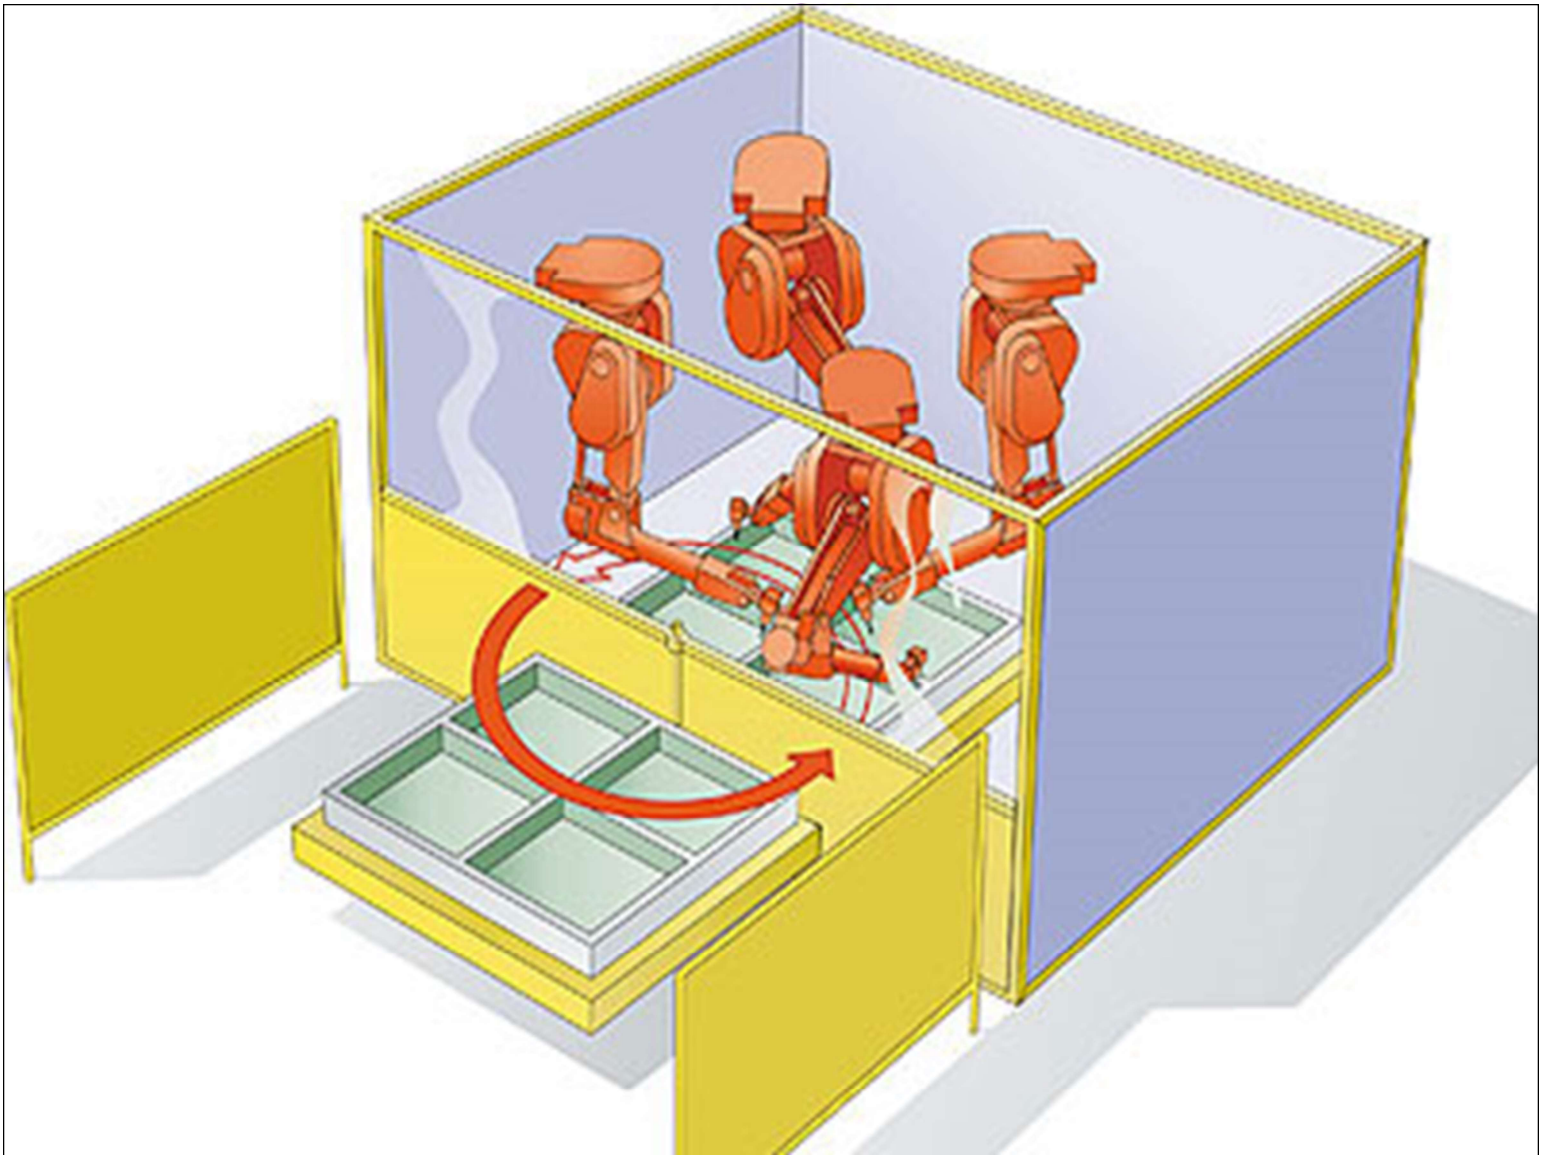
One of my former employers made automobile carpets for two well known luxury car manufacturers Part of the carpet making process involved trimming the edges and cutting the carpets to shape. The technology used to cut the carpets was high pressure water jets.

The system of process involved a turntable that had mounted on to it two jig tools that the carpets would be placed on and then the turntable would rotate 180 degrees into the sealed water jet cutting booth. As one carpet was being cut and trimmed the carpet that had just been processed was removed and another carpet to be cut and trimmed was then placed on the turntable jig tool in readiness for processing - this was done internal to the operation.

In order for the carpet to be place on and removed from the turntable jig tool with not too much physical exertion for the people loading and unloading carpets it was designed to tilt down to a 45° degrees angle. This did make the job a little less labor intensive.

However, where one ergonomic problem was made less painful for the operators, another problem was created. The jig tool would tilt down outside of the water retention tray – see next picture slide...

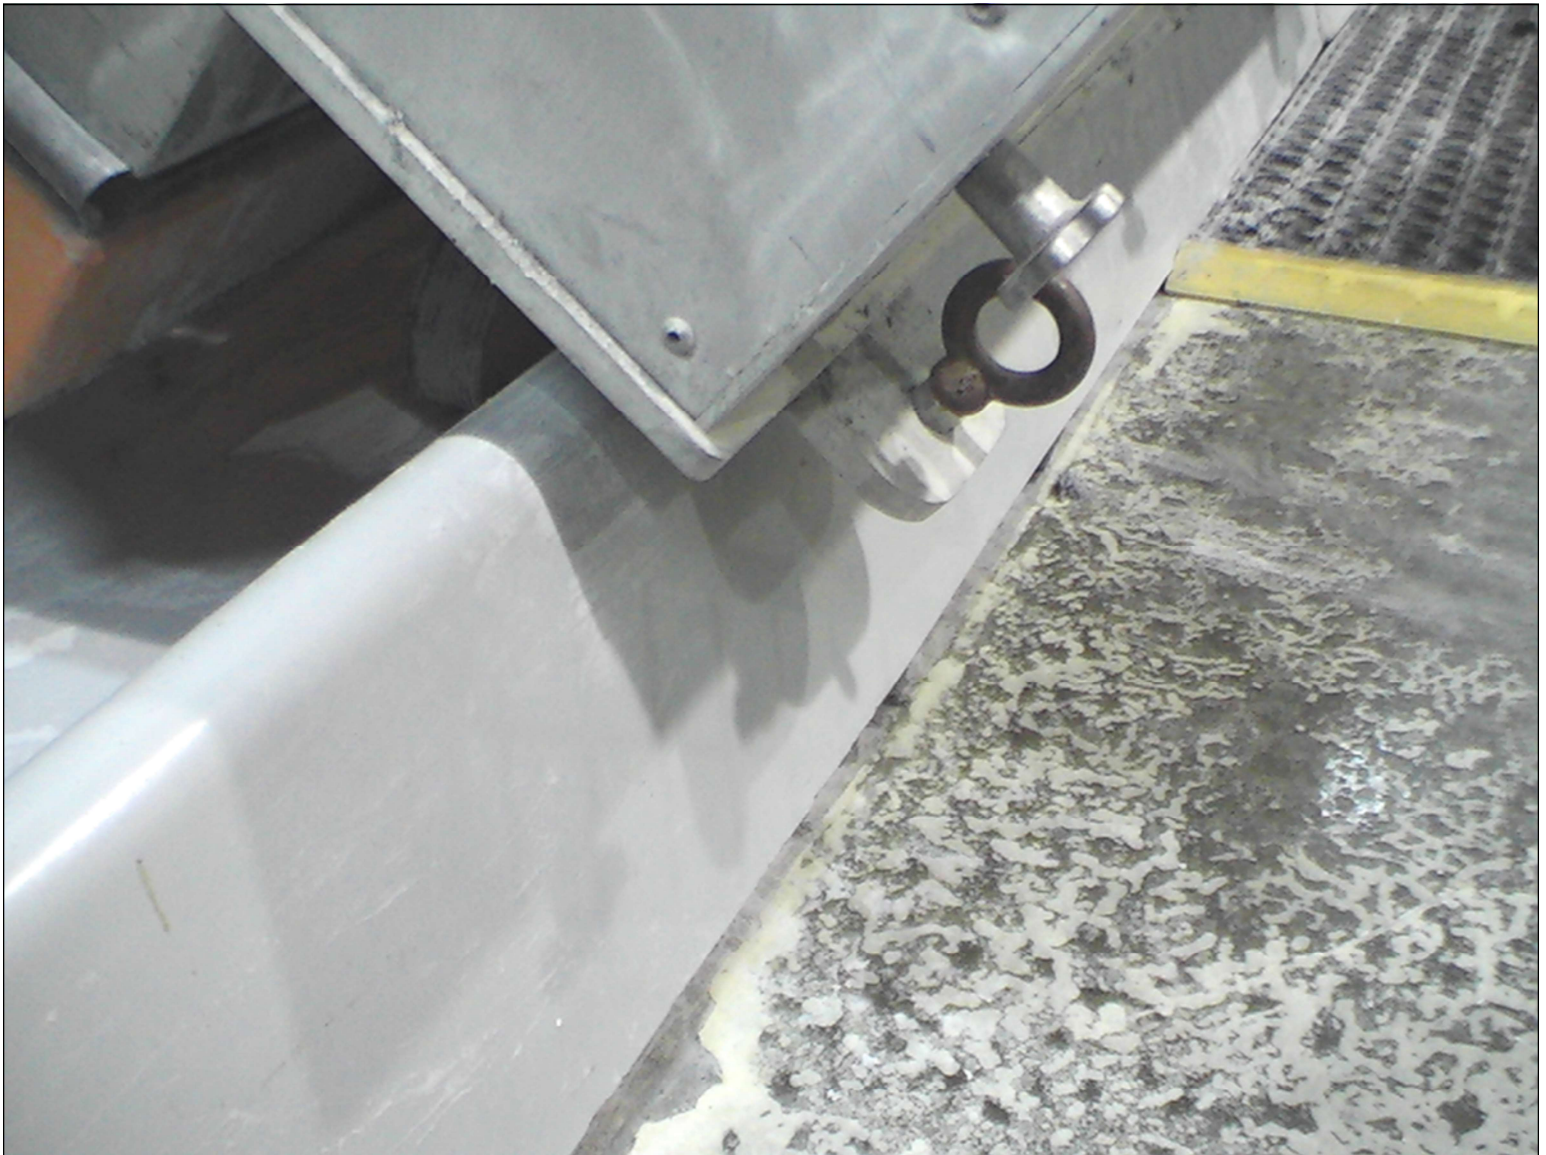
Residual water left trapped inside the nooks and crannies of the inter-webbing underside of the jig tool would drip down on to the floor right in the area of where the operators loaded and unloaded the carpets. A constant puddle of water was on the floor. This was not only a slipping safety hazard, but it was also a tripping hazard as the operators would throw boxes of rags on the floor in an effort to soak up the water, several times people slipped or tripped - plus it was unsightly, the cost of rags and it was a hassle to clean up at the end of the shift...

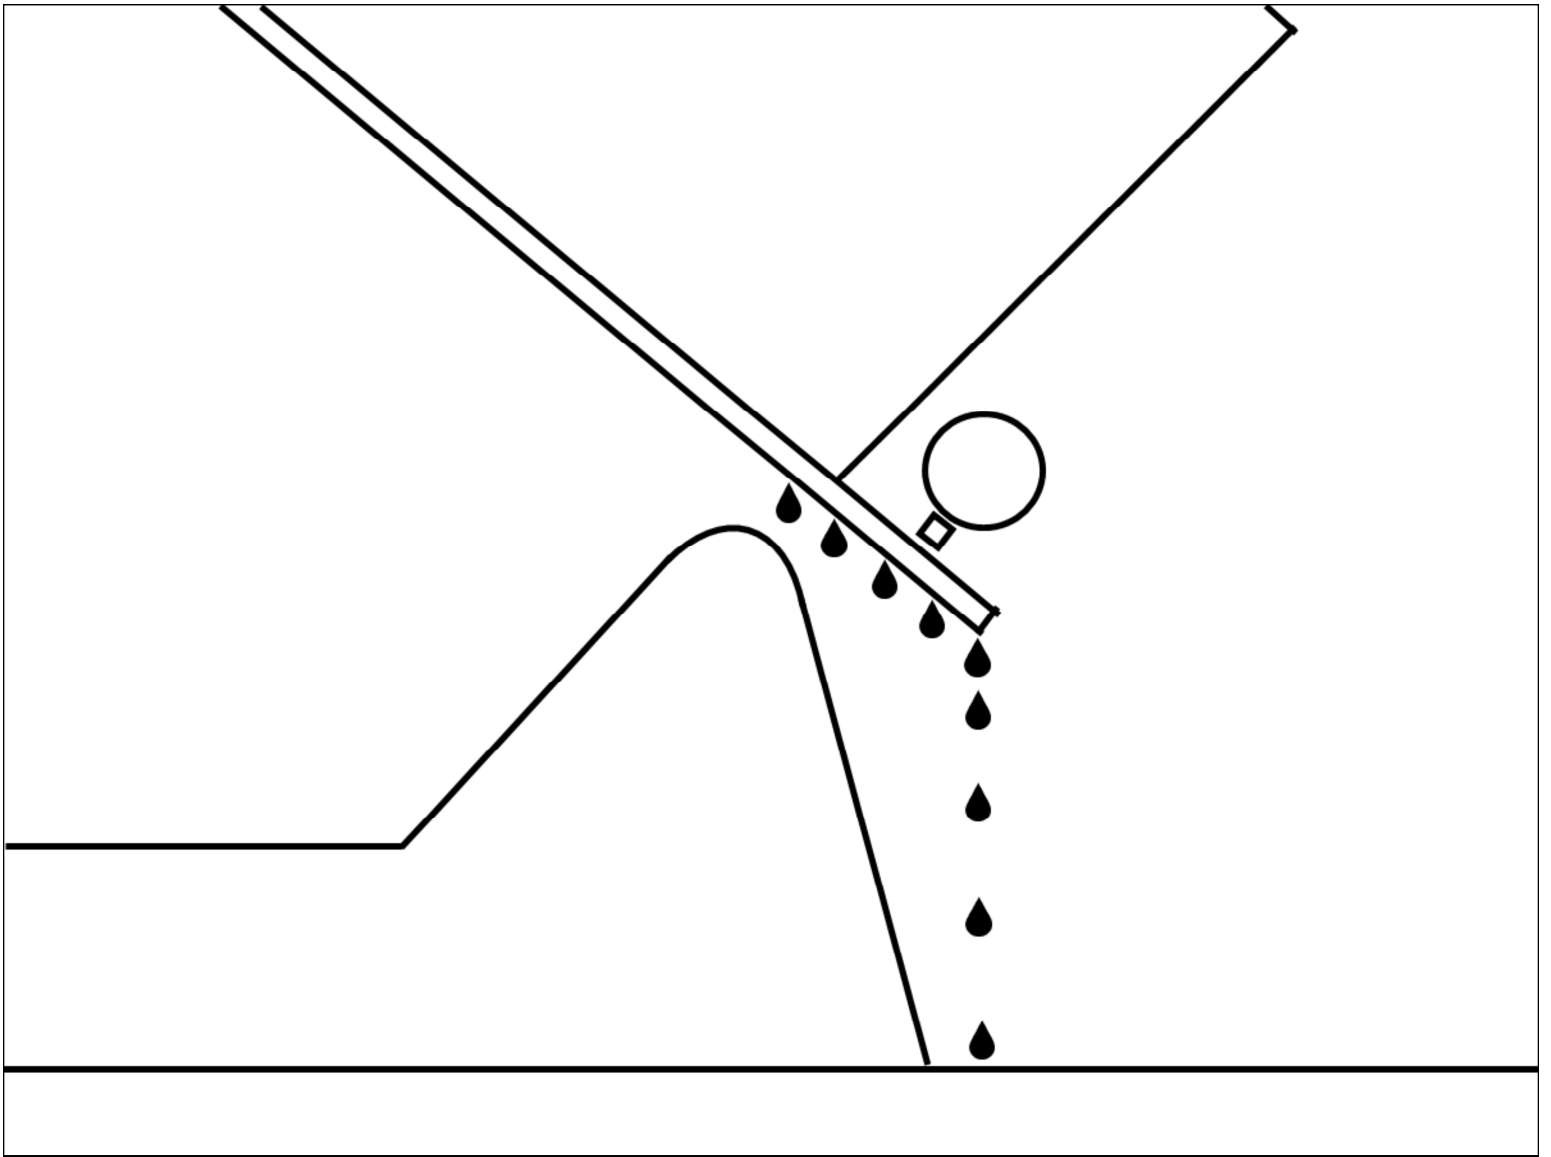
Diagram illustrating the water dripping outside the water retention tray on to the floor.

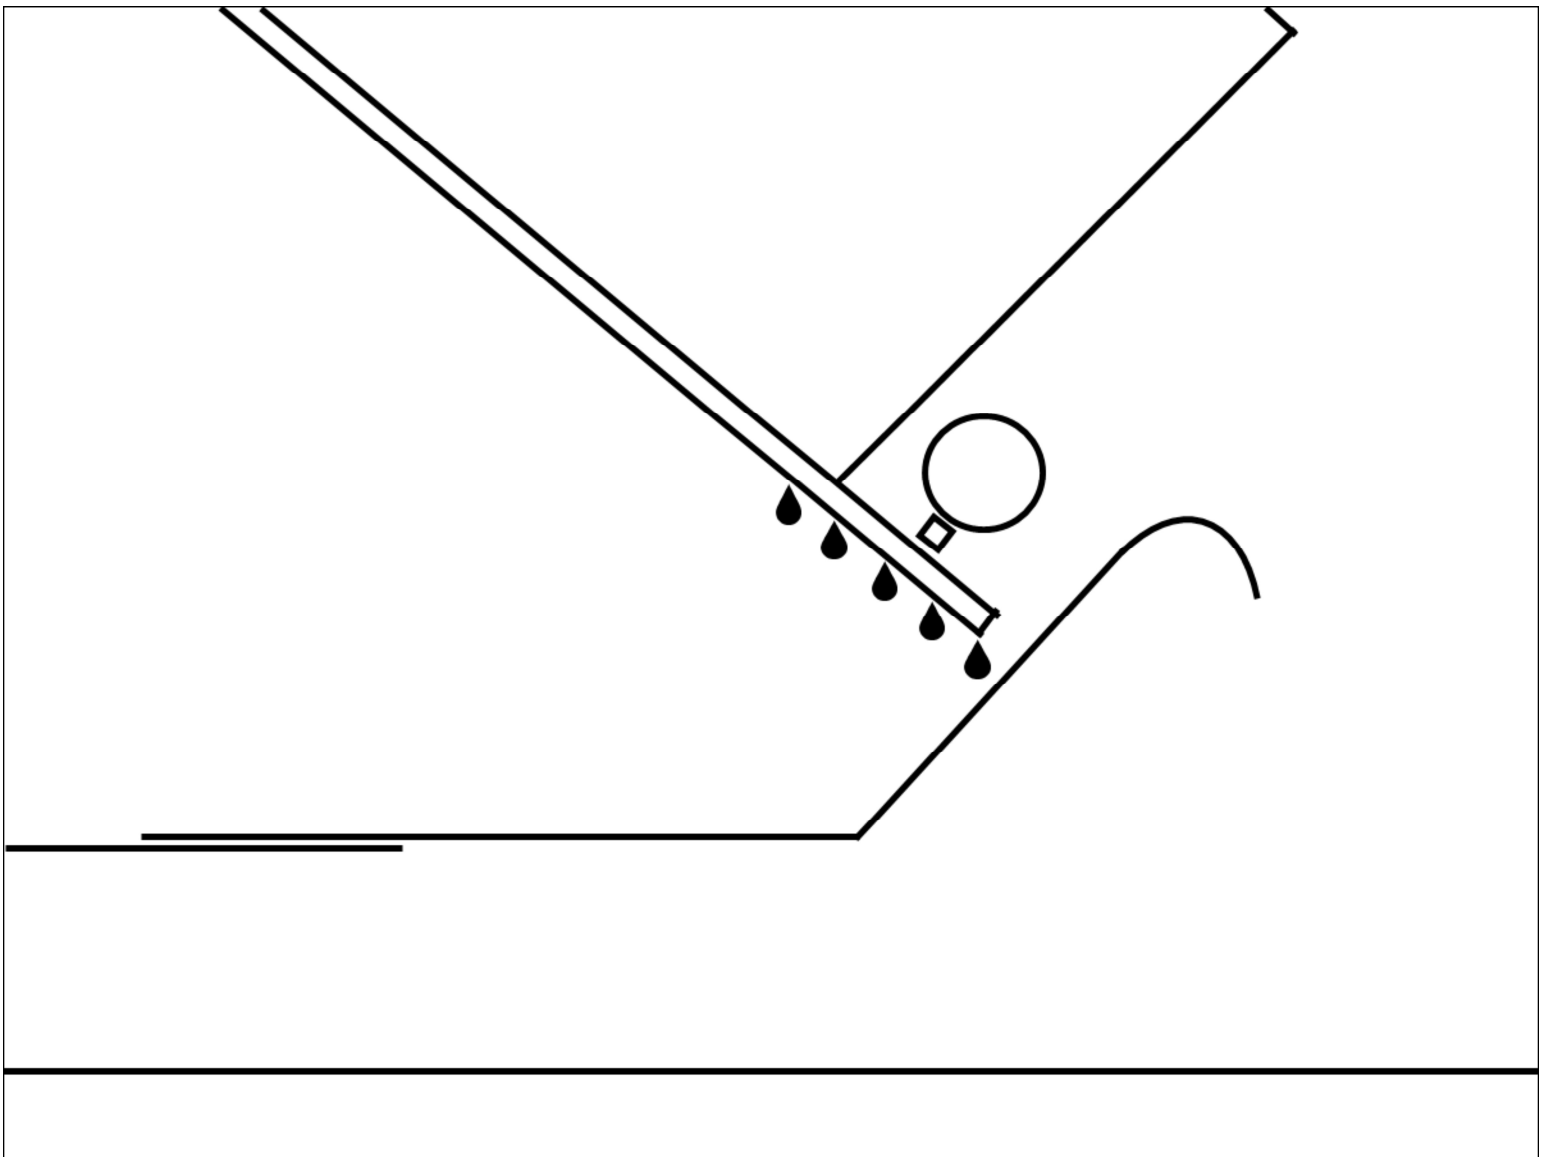
It was a fundamental design flaw that measures were not taking to allow for the tilting of the turntable jig tool. I contacted the manufacturer of the water jet cutting booth asking them if a wider water retention tray was available, none where.

I had to re-design by modification the water retention tray myself to successfully eliminate this problem. I designed a 10ft feet long by 5ft feet wide 1/8" gauge 316 stainless steel extension piece to extend the width of the water retention tray.

I had a local fabrication shop make the extension pieces and then we cut out a section of the existing fiberglass water retention tray and installed the stainless steel extension, popped riveted it in place and sealed it up with caulking.

I did this to all 4 water jet cutting processes - Problem eliminated...

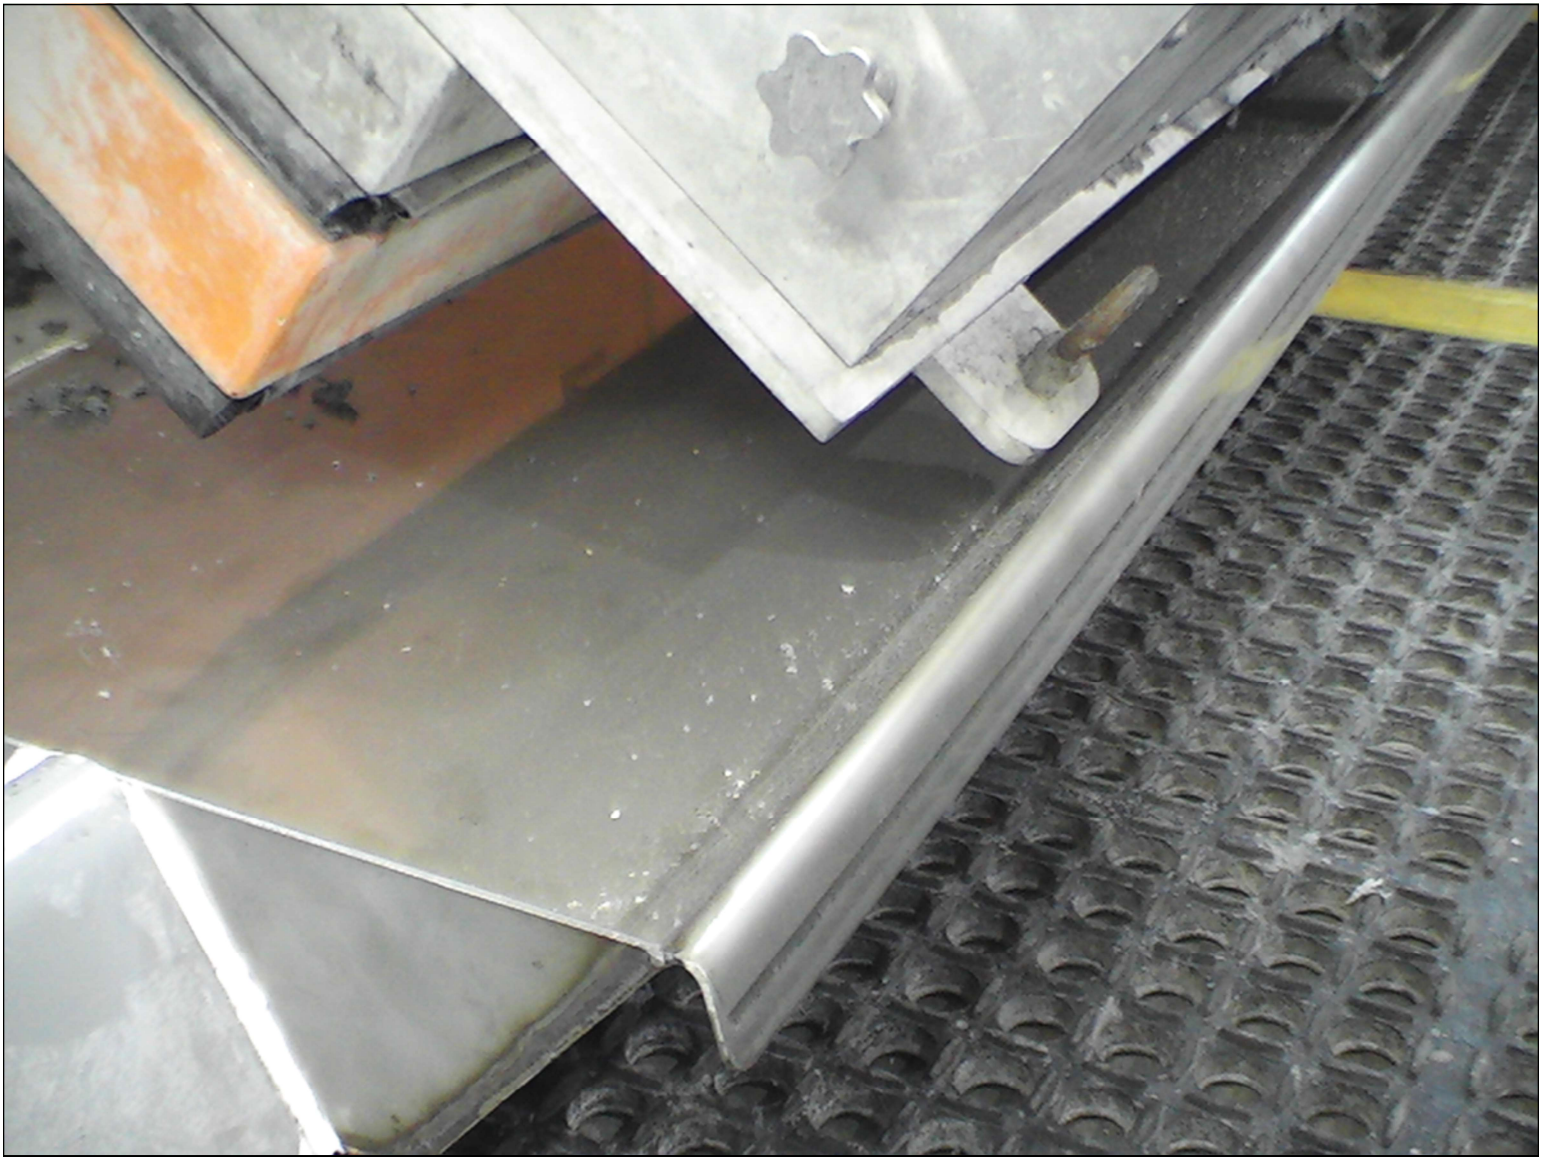
Stainless steel water retention tray extension shown installed.
